SOIL-PILE INTERACTION IN SOFT SOILS

PhD Dissertation

AARHUS
UNIVERSITY
DEPARTMENT OF ENGINEERING

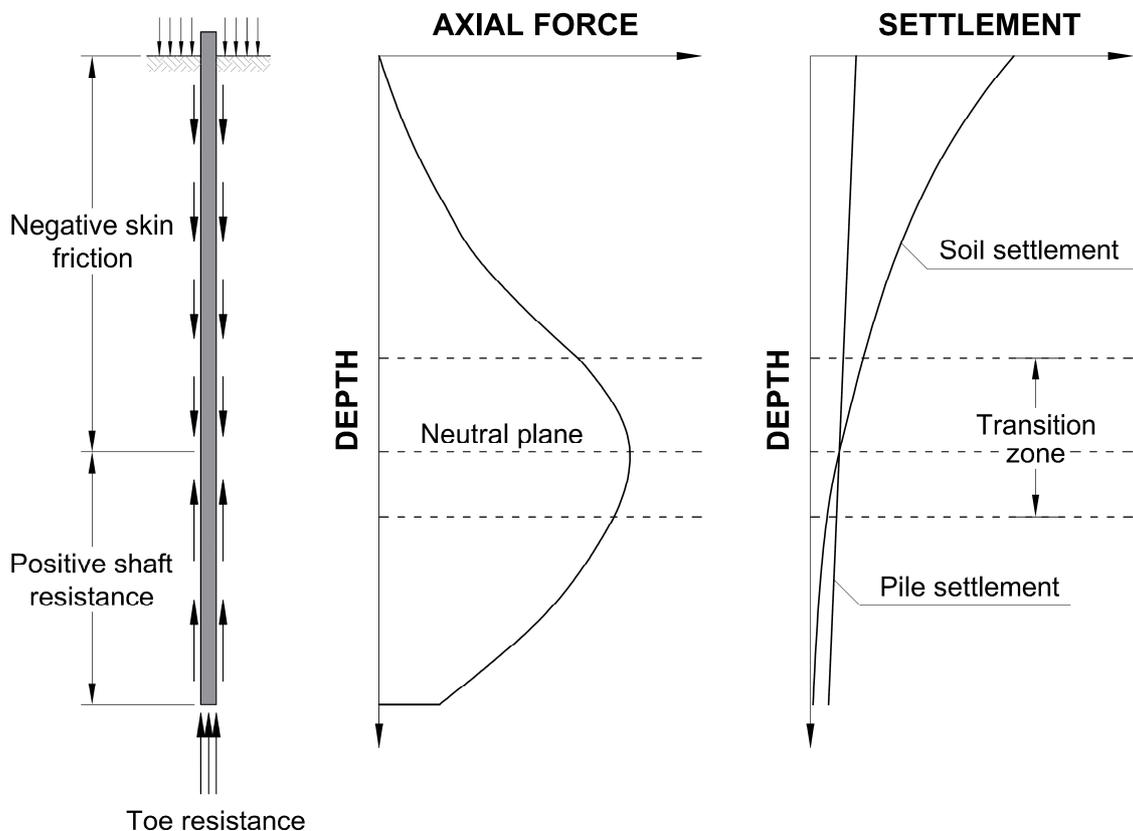
The design of piled foundations in soft, subsiding soils is a complex soil-pile interaction problem. As presented in Figure 1, soil settlement will develop negative skin friction along the upper length of a pile and positive shaft resistance along the lower length. At a depth called “neutral plane”, a force equilibrium exists between the sum of the sustained load on the pile plus the force accumulated due to negative skin friction (drag force) and the sum of the positive shaft resistance and the mobilised toe resistance. The neutral plane is also the settlement equilibrium between the pile and the soil, i.e. there is no relative movement. A transition zone develops above and below the neutral plane, at which the unit shaft resistance changes from a negative to a positive direction of shaft resistance. The length of the transition zone depends on the relative movement between the pile and the soil (Fellenius 2020).

Figure 1. Soil-pile interaction in soft soils (a concept without the sustained load)

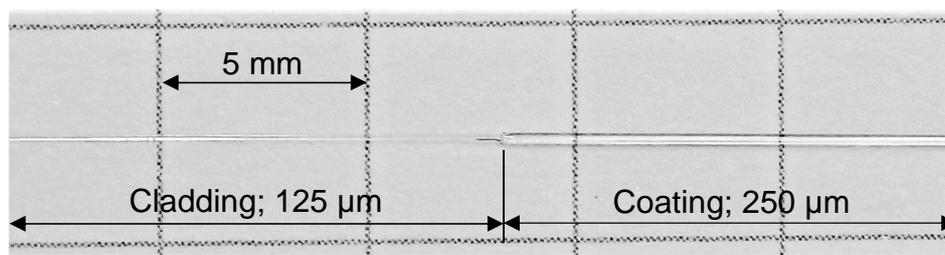
Figure 2. An example of a bare fibre.

The installation of DFOS in various structures has been described in detail by Kechavarzi et al. (2016). Even though it is well described, a successful installation of fragile DFOS sensors in a structure, as presented in Figure 2 and Figure 3, is a challenging task. Additionally, the DFOS systems are based on light scattering, which is sensitive to any micro- and macrobends. These distortions, together with contaminated connectors and unnecessary splices, cause an optical power loss and affect the performance of the monitoring system.

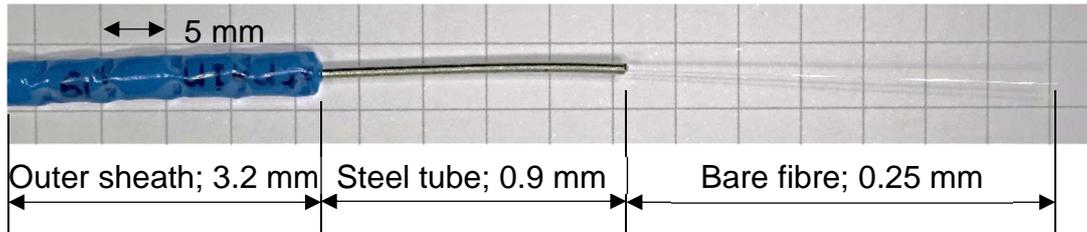
Figure 3. An example of a strain cable.

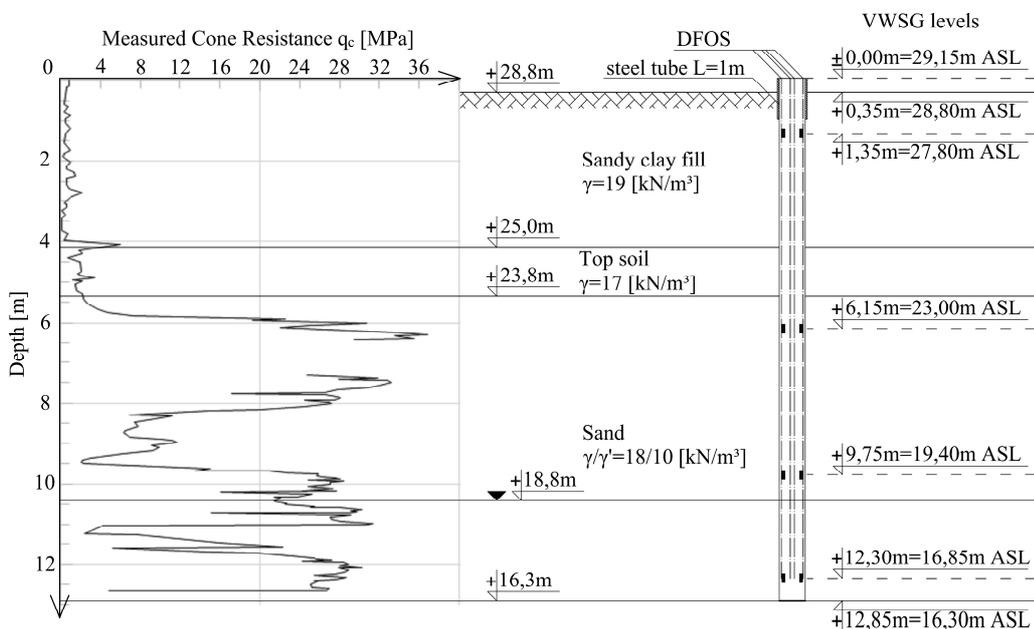
The boring and CPT profile nearest to the test pile indicate a soil profile consisting of 3.8 m sandy clay fill underlain by a 1.2 m thick layer of buried soft organic sandy clayey top soil on top of sorted late glacial meltwater sand, cf. Figure 1. The meltwater sand continues well below the pile toe and increases in coarseness with depth. Based on the measured cone resistance, q_c from CPT testing, the sand can be classified as medium to very dense. The groundwater table is located at level 19 m ASL (above mean sea level) around 2.7 m above the toe of the test pile.

Figure 1. Soil profile and the test pile.

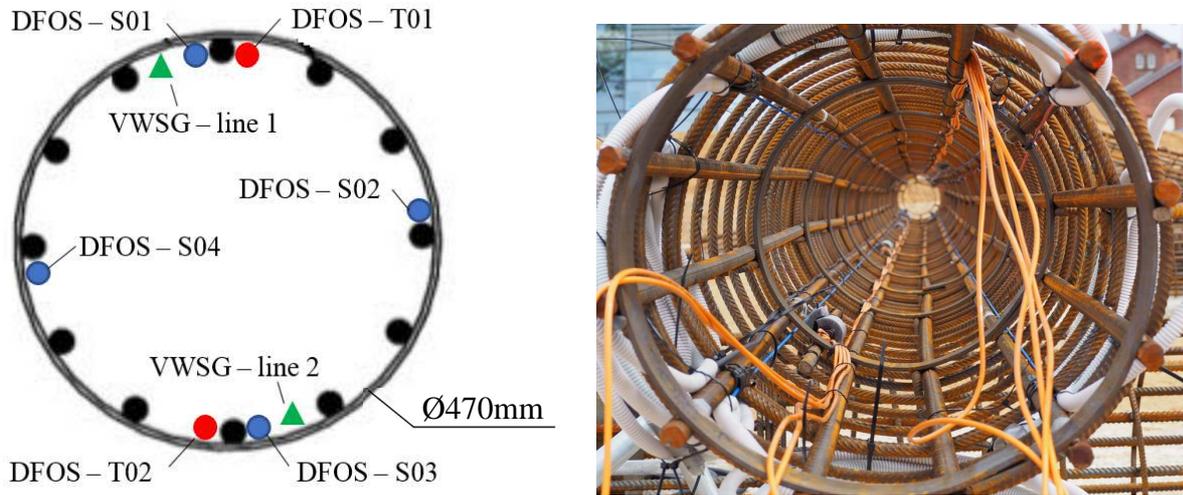
Figure 2. Cross-section of the reinforcement cage showing instrumentation.

Figure 2 shows a photo and illustration of the cross-section of the test pile. As shown in Figure 2 the test pile was instrumented with four lines of strain and two lines of temperature distributed fibre optical sensors (DFOS). A BRUsens V9 strain cable, a BRUsens temperature cable and a standard loose tube gel-filled fibre optical cable (temperature sensor) was used in this case study. The fibre optical sensing cables were fixed to the main reinforcing bars from the pile head to the pile toe. All of strain distributed optical fibre sensing cables were pre-stained to about $700\mu\epsilon$ (cf. Figure 3). Temperature sensing cables were attached on diametrically opposite sides alongside the strain cables as presented in Figure 2. To measure strain and temperature changes, an optical reflectometer based on Rayleigh back scattering was used. The interrogation unit provides data with resolution of about $\pm 1,0\mu\epsilon$ for strain and about $\pm 0,1^\circ\text{C}$ for temperature measurements. A spatial resolution was set to 2,6 mm. Detailed description of Rayleigh-based distributed fibre-optical sensing techniques was presented by Palmieri and Schenato (Palmieri and Schenato, 2013).

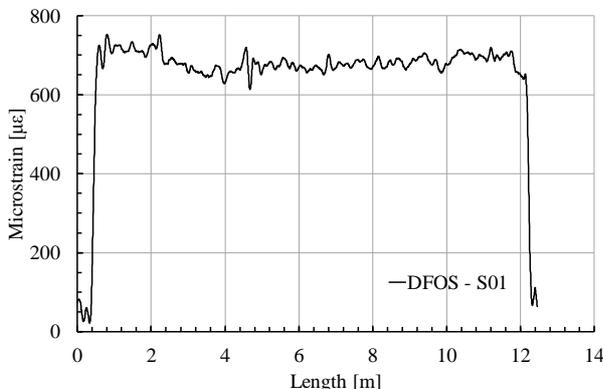
Figure 3. Pre-straining of the fibre optical cable - DFOS-S01.

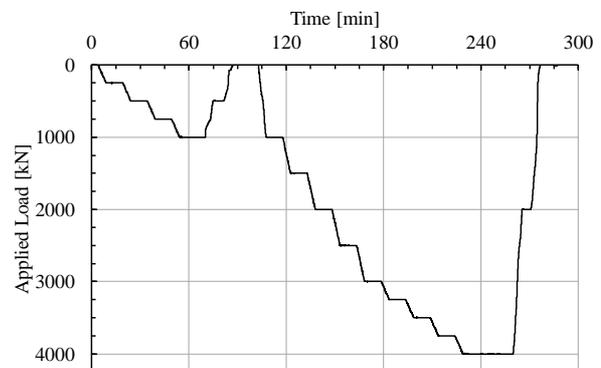
Figure 6. Schedule of the test (Aamann-Svale and Møller, 2017).

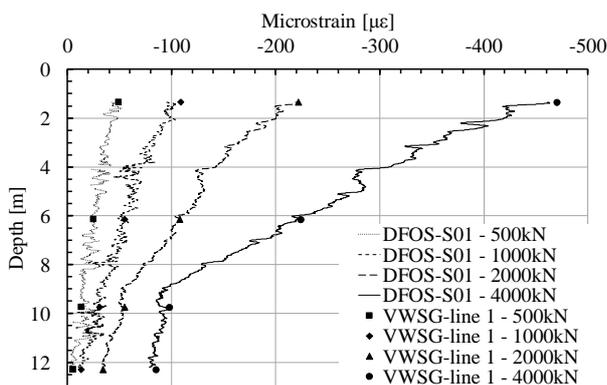
Figure 7. Measured strain distribution of the test pile for selected load steps obtained from VWSG-line 1 and DFOS-S01.

From Figure 7 and Figure 8 a very high correspondence is observed between strain measurements from the vibrating wire strain gauges (VWSG) and distributed fibre optic sensors (DFOS) at the locations of the VWSG. The correspondence of strain measurements is further illustrated in Figure 10 for measurement taken during all load steps.

However, it is also clearly illustrated that distributed fibre optic sensors provide a much more detailed strain profile, which is not possible to obtain from interpolation between the spot measurements using VWSG. For example, it is seen that the soft soil layer located above the sand layer between a depth of 4.1 m and 5.3 m appears to be distinguished from DFOS measurements (constant strain). Furthermore, from Figure 7 the strain profile is shown to yield sharply in the lower part of the test pile (VWSG-line 1 and DFOS-S01) and the exact depth at which it occurs can be clearly seen from the strain profile obtained from DFOS, while the spot measurements only indicate an approximate level.

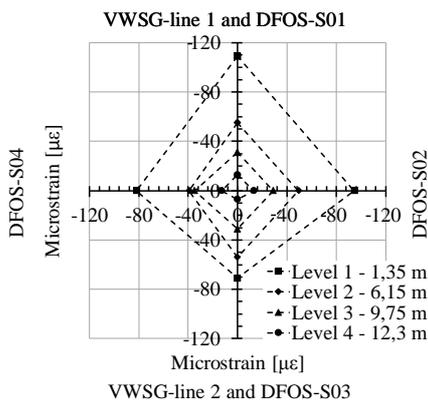
Figure 9. Cross-sectional distribution of strains at four different levels under the pile head load of 1000 kN.

The non-uniformity of strain measurement in different cross-sectional locations and at different levels under the same applied load at the pile head is further illustrated in Figure 9. Although, the strains are non-uniform in the cross section and varies with depth, it is found that if the average strain of opposing strain measurement are compared, then the strain measurements are in very good agreement; e.g. average of VWSG-line 1 and VWSG-line 2 vs. average of DFOS-S02 and DFOS-S04.

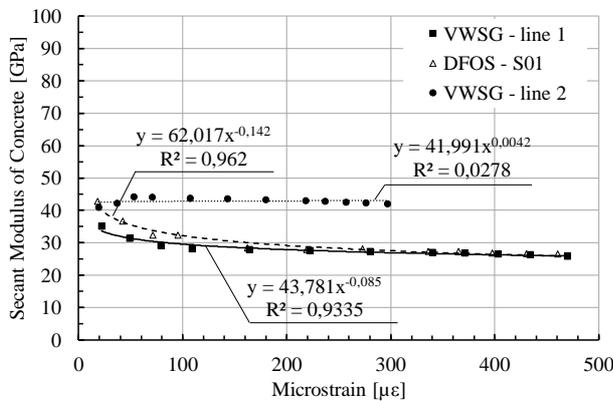
Figure 11. Back-calculated secant modulus of concrete.

In Figure 11 the back calculated secant modulus of concrete from VWSG-line 1, VWSG-line 2 and DFOS-S01 strain measurements are plotted against microstrain. It is found that the back calculated secant modulus of concrete from VWSG-line 1 and DFOS-S01 strain measurements are in good agreement, specially at strains above 150 $\mu\epsilon$. The secant modulus of concrete is seen to reduce from around 35-45 GPa at 20 $\mu\epsilon$ to around 29 to 30 GPa at 150 $\mu\epsilon$. Above 150 $\mu\epsilon$ the modulus is seen only to reduce slightly with increasing strain. The evolution of the secant modulus with strain may with good precision be described by a power function, as shown in Figure 11, as given by the following equations:

The concrete modulus was back calculated assuming that the load at the first layer of VWSG (1,35m below the pile top) and DFOS was equal to the applied load at the pile head. Furthermore, it is assumed that the concrete modulus is uniform along the pile length. It has not been possible to back calculate the concrete modulus using the tangent method from the lower levels of the pile from the test results, as full shaft resistance may not have been mobilised.

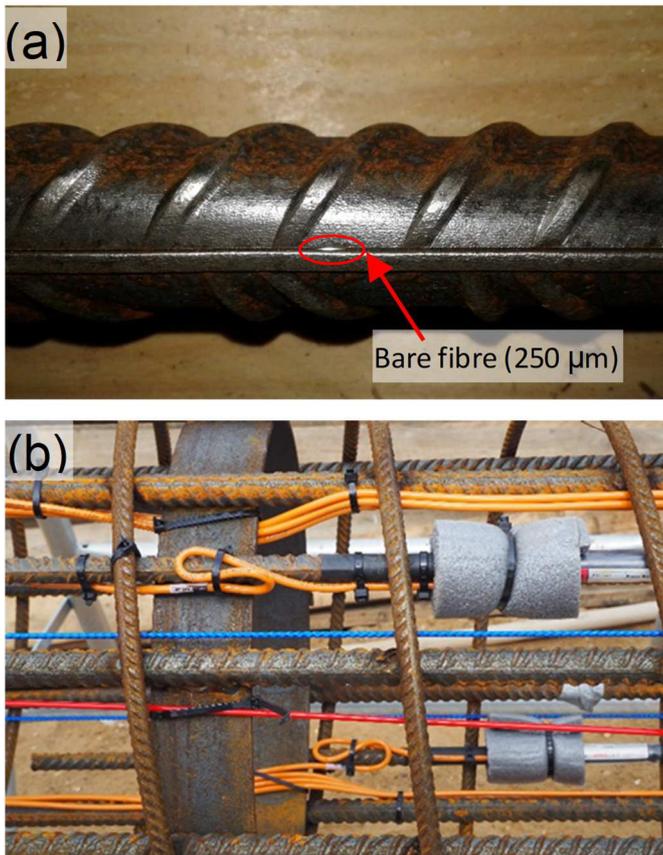
Figure 2 An example of (a) a bare fibre glued to the reinforcement bar along the longitudinal rib and (b) FO strain (blue) and temperature (red) cables attached to the reinforcement cage. The "250 µm" label refers to the thickness of the fibre cable

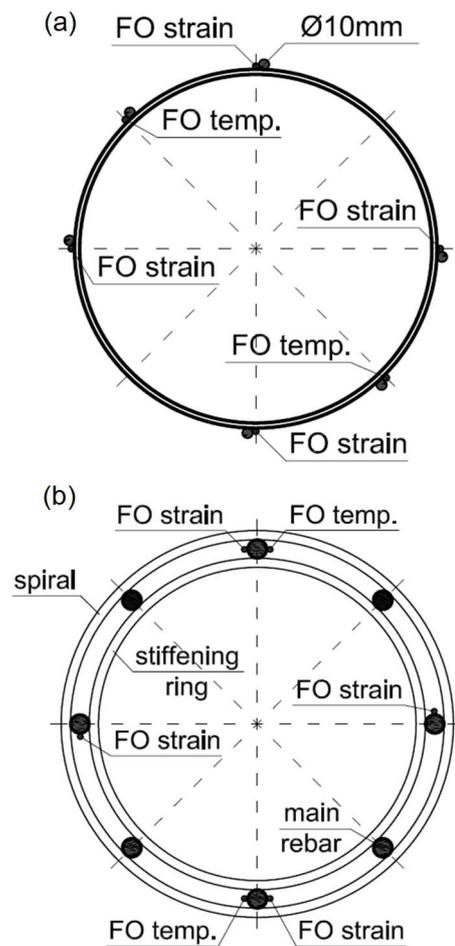
Figure 3 shows a typical cross-section layout of an instrumented (a) steel pile and (b) a reinforcement cage of a bored pile. It is good practice to install at least one pair of opposite mounted strain sensors, because it is very likely that the pile will be subjected to bending. Installing two pairs will ensure a back-up redundancy in case of damage to the FO cable, or provide a valuable independent verification (confirmation) of unexpected results. Because the FO system provides continuous measurements, the location of sensors with depth is not an issue.

Figure 3 Typical cross-section layout of FO cables attached to (a) a steel pile and (b) a bored pile

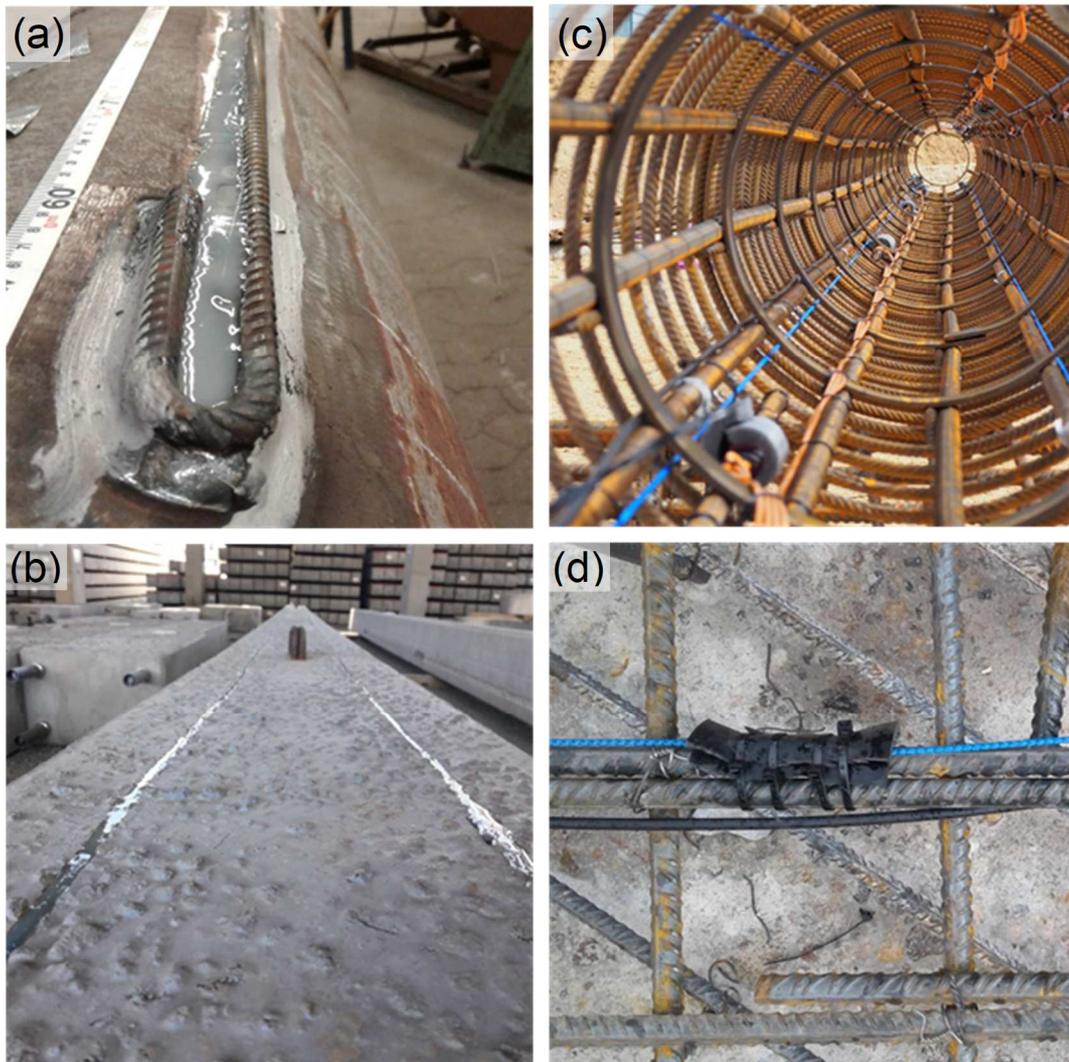
Figure 4 FO cable installation in piles: (a) glued to a steel pile, (b) glued in a groove cut along a precast concrete pile, (c) attached to a reinforcement cage, (d) attached to a rebar

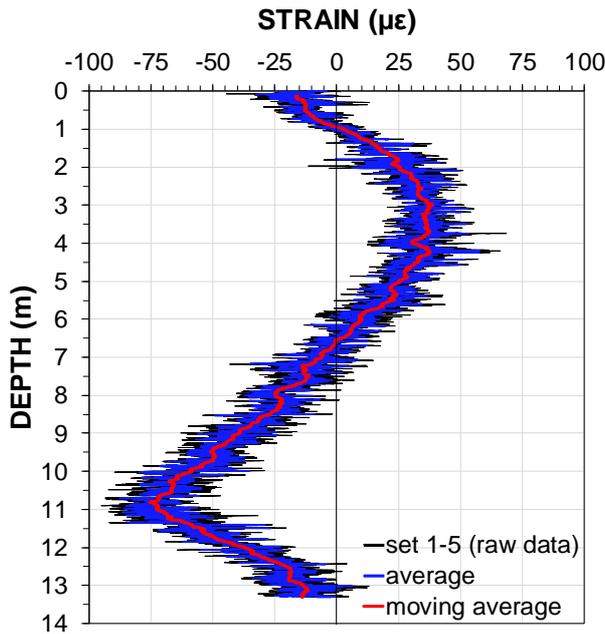
Figure 7 An example of raw and smoothed strain data obtained from an individual strain FO cable

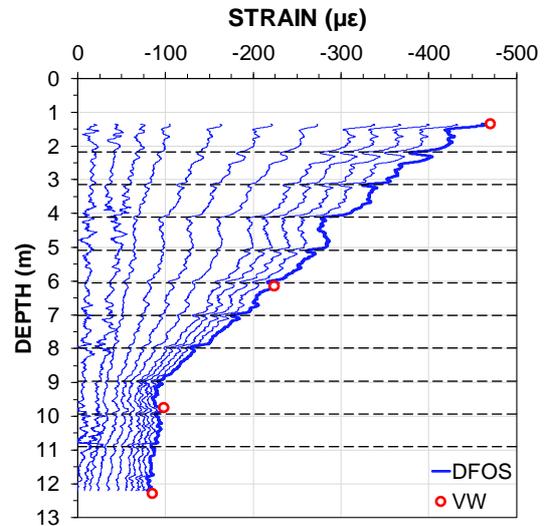
Figure 9 Strain distributions obtained from FO (all load increment) and VW sensors (the last load increment). The dashed, black lines indicate the location of stiffening rings (every 0.97 m)

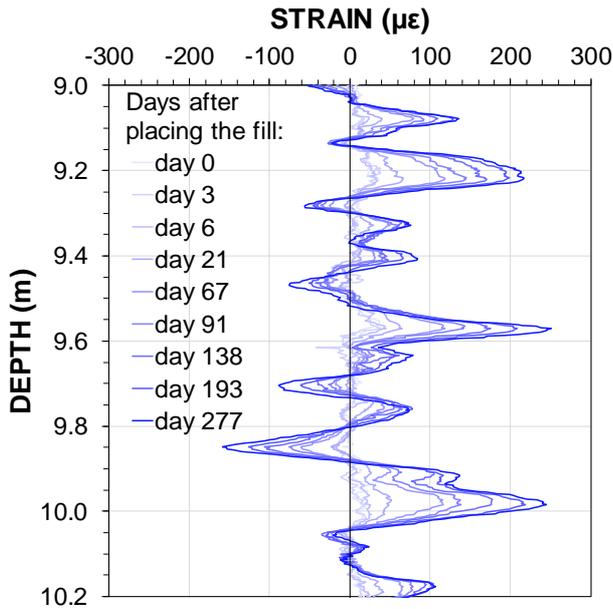
Figure 10 Evolution of cracks along precast concrete pile (raw strain from one of the strain FO cable mounted on the pile)

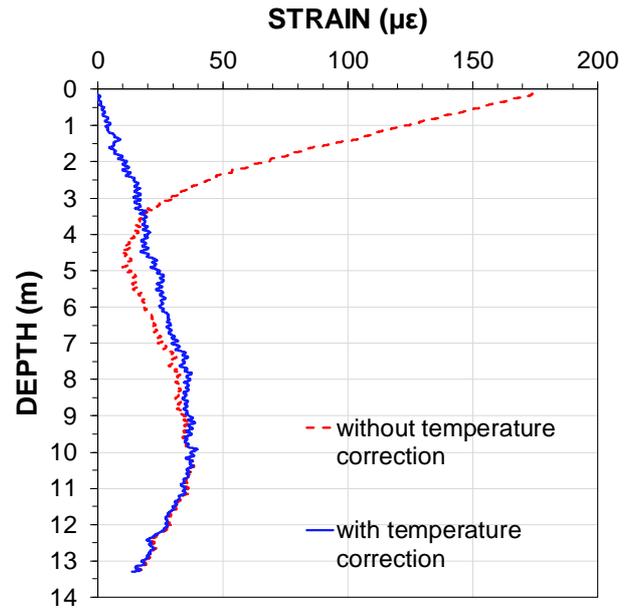
Figure 12 An example of the influence of temperature on the change of strain measured as average of two pairs of FO cables between Sep. 6, 2018 and Jan. 30, 2019

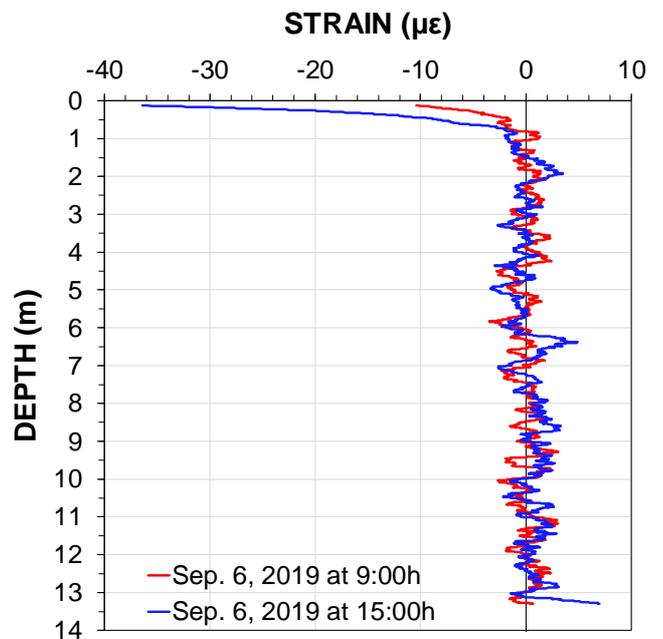
Figure 13 An example of the influence of daily ground temperature changes on the individual FO strain cable on Sep. 6, 2018 from an initial reading taken the same day at 06:30h

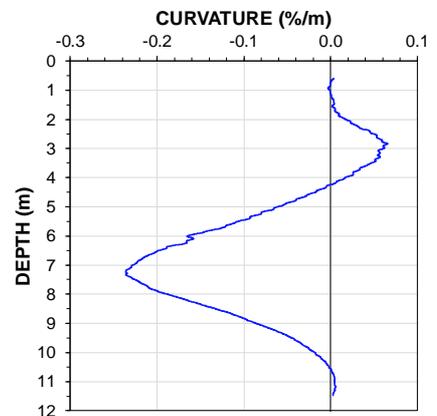
Figure 16 (c) curvature of the steel test pile recorded 126 days after driving

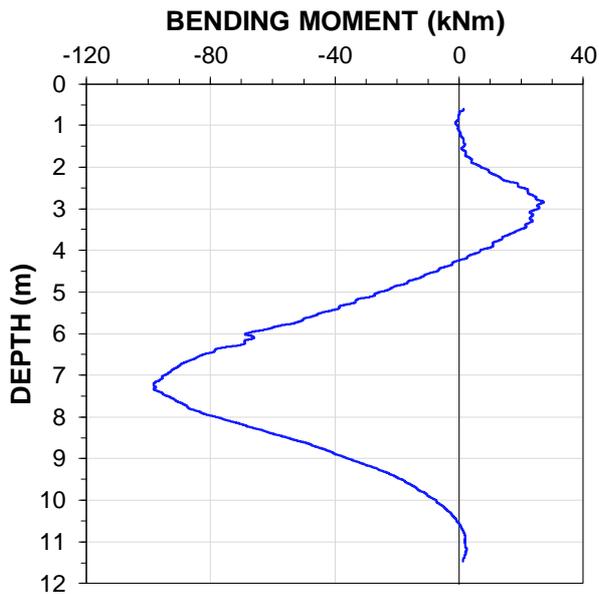
Figure 17 (a) Bending moment diagram

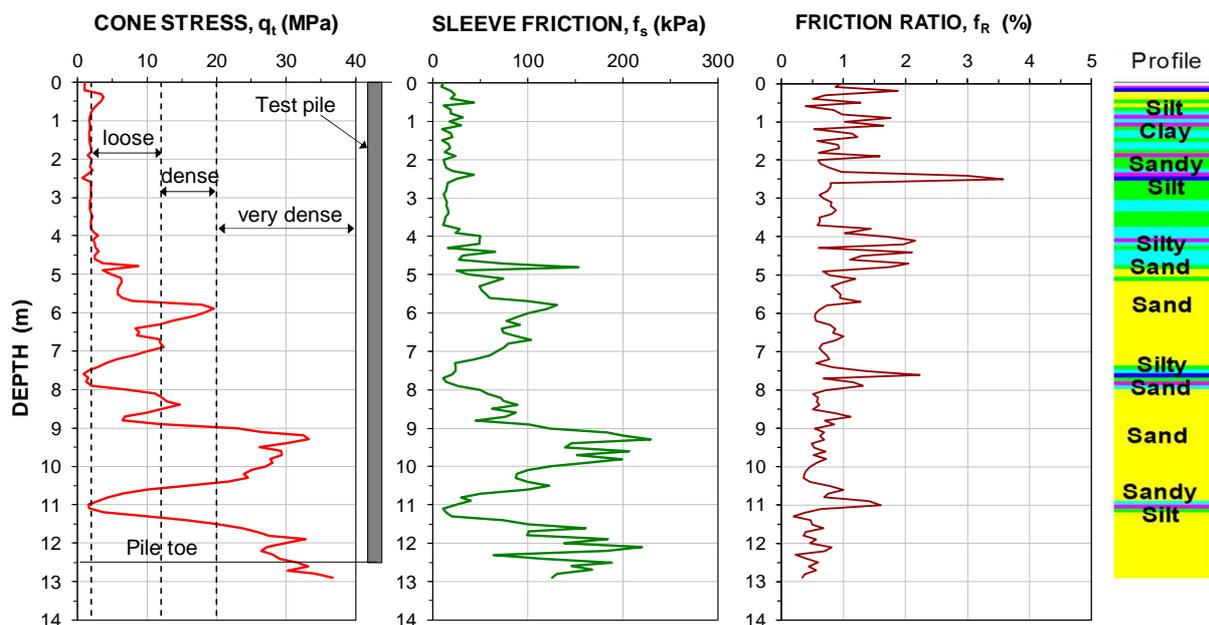
Figure 1. Results of a CPT sounding pushed 8 m from the test pile.

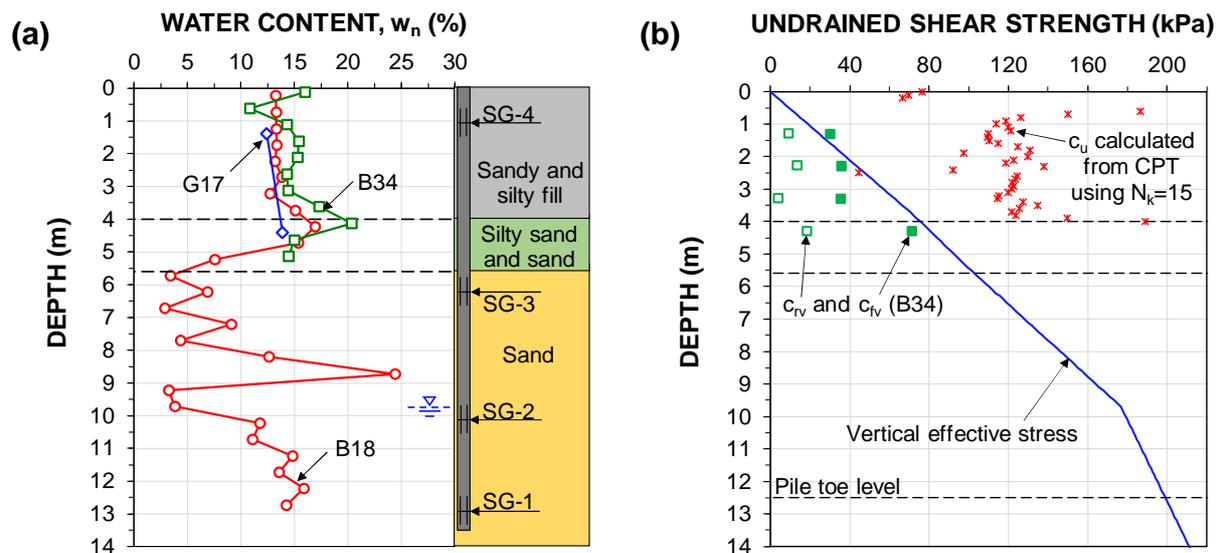
Figure 3. (a) Soil profile and distribution of water content. Data are from three soil borings: B34 (performed in October, 1989; 13 m from the test pile), B18 (performed in December, 2014; 27 m from the test pile), and G17 (performed in June, 2016; 8 m from the test pile); (b) undrained shear strength determined from the field vane test (peak, c_{fv} , and remolded, c_{rv}) and CPT and the distribution of vertical effective stress.

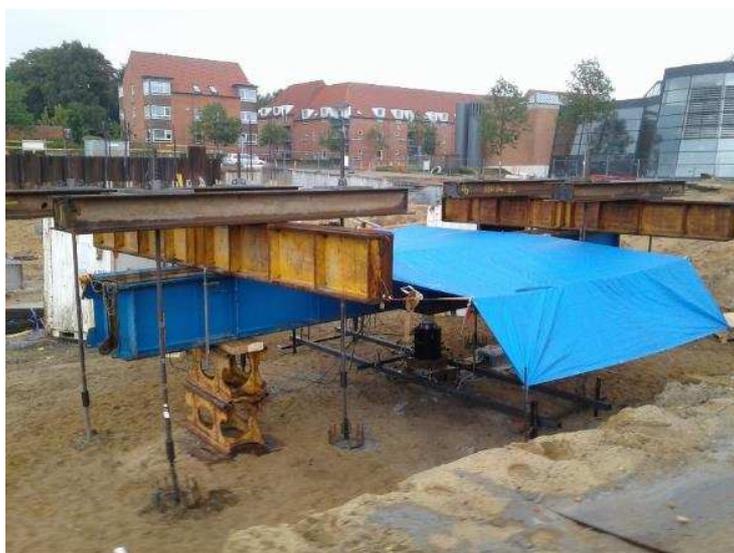
Figure 4. The test setup.

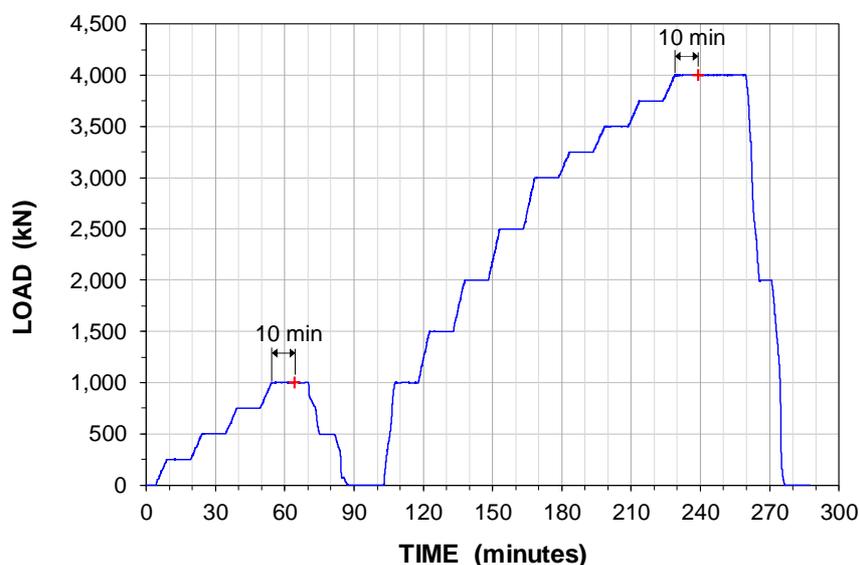
Figure 5. Load-time schedule (Data from Aamann-Svale and Møller 2017).

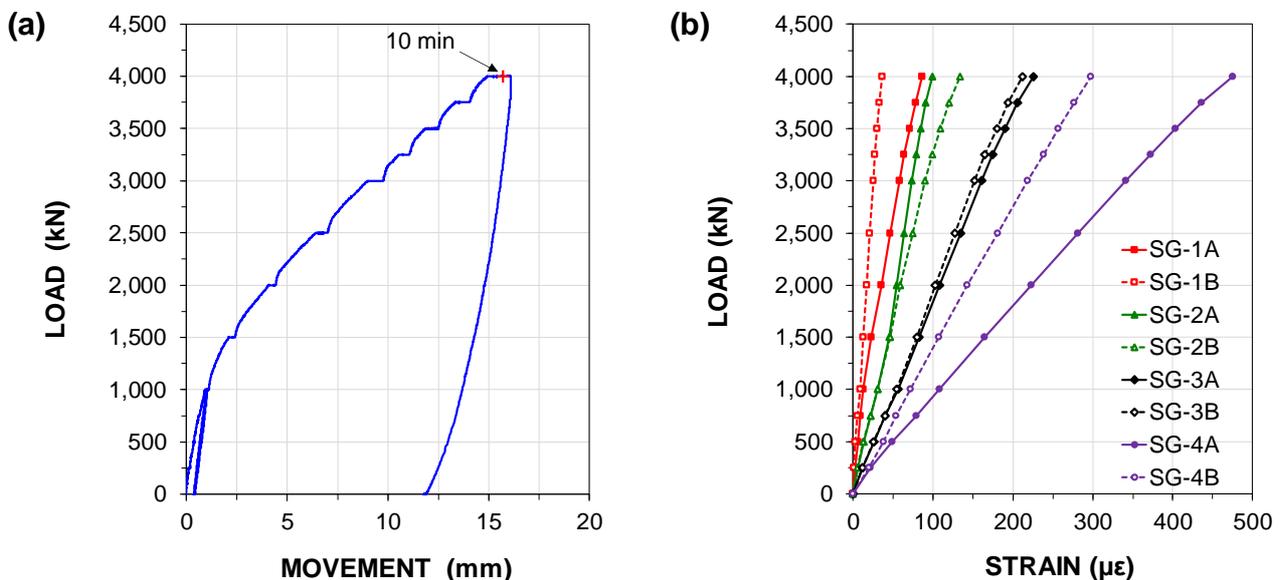
Figure 6. (a) Load-movement records of the test (Data from Aamann-Svale and Møller 2017); (b) strains measured at last reading for each gage level.

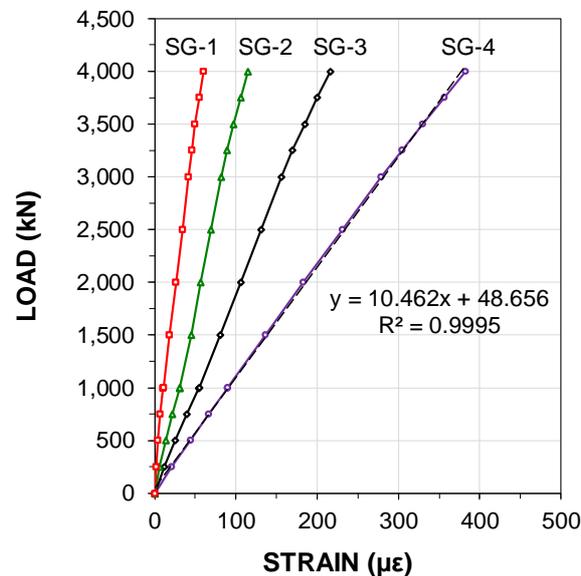
Figure 7. Load-strain from strain-gage levels SG-1 to SG-4 (last reading at each load-level).

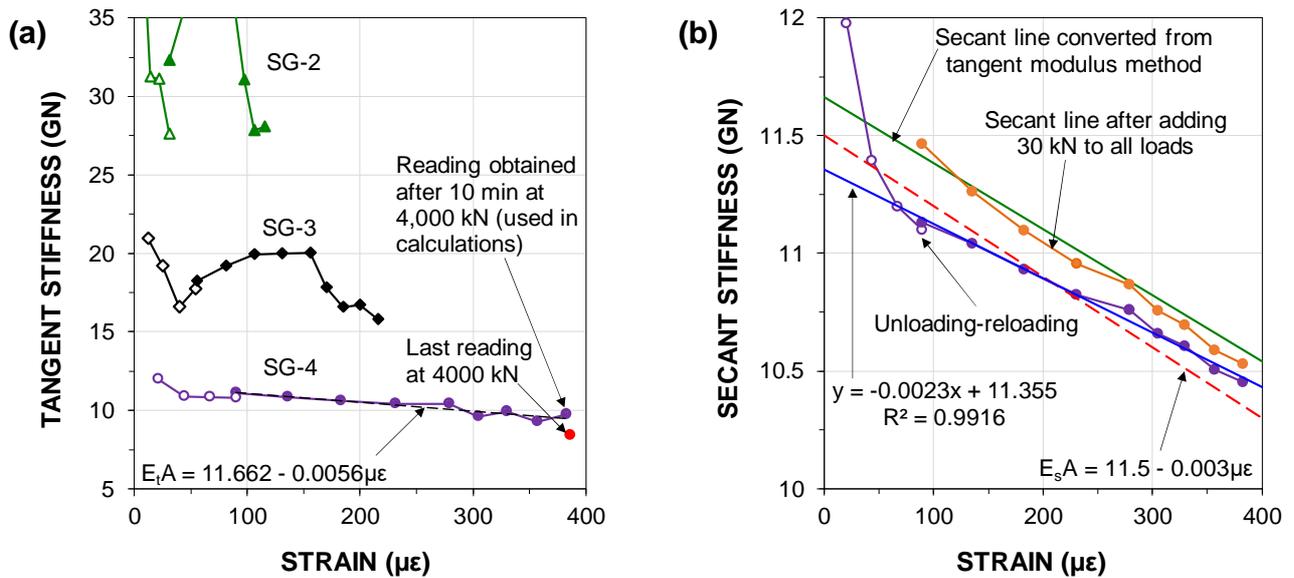
Figure 8. (a) Load-strain from strain-gage levels SG-1 to SG-4; (b) secant stiffness versus strain from SG-4.

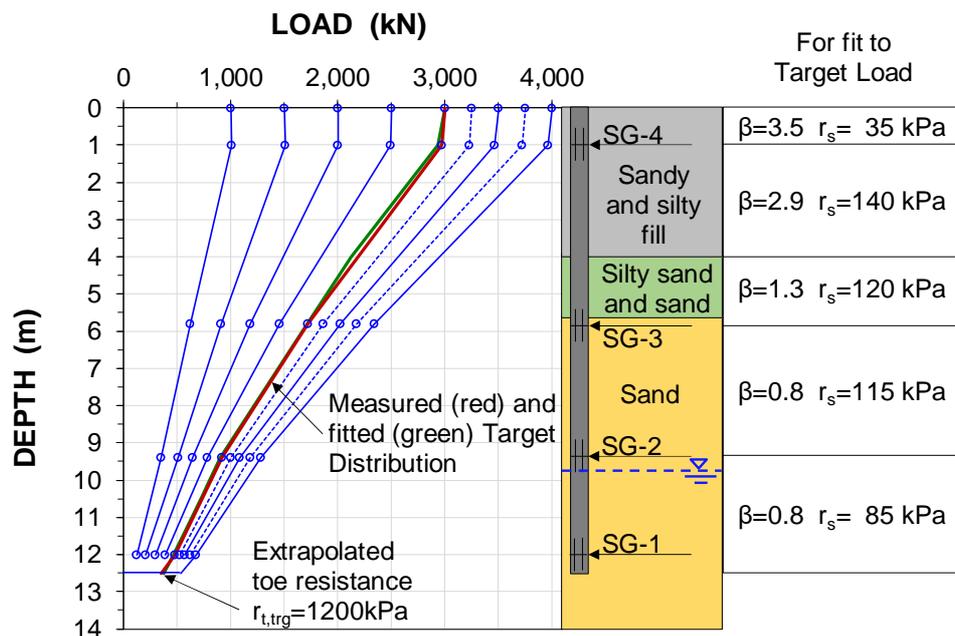
Figure 9. Measured and fitted load distributions.

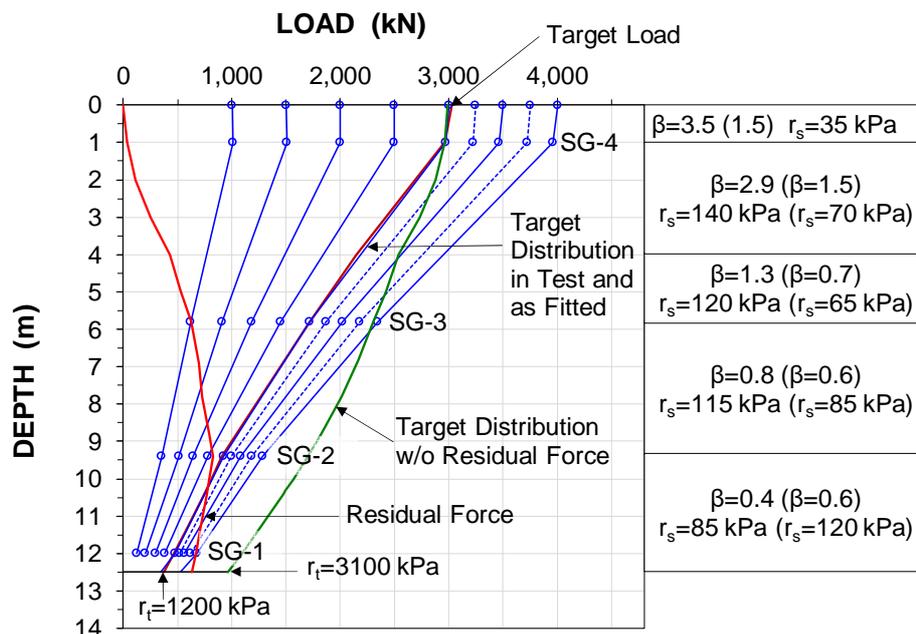
Figure 10. Back-calculated load distributions and distribution for the Target Load with and without residual force.

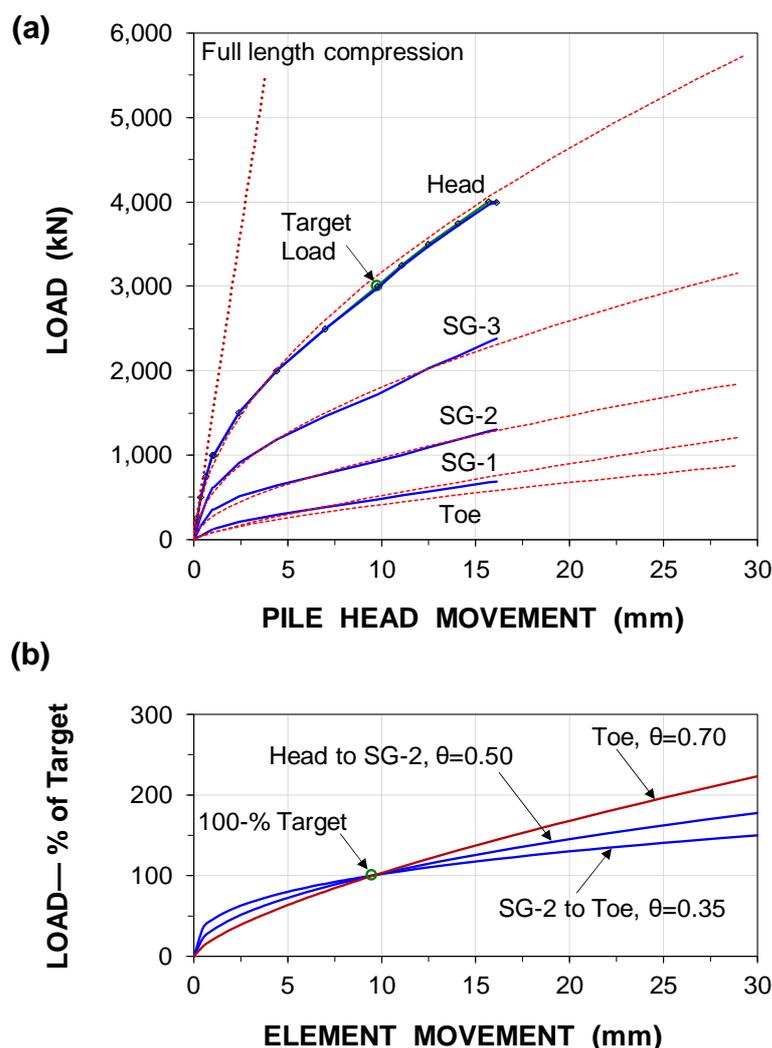
Figure 11. (a) Measured and fitted load-movement curves and (b) the associated t - z / q - z curves.

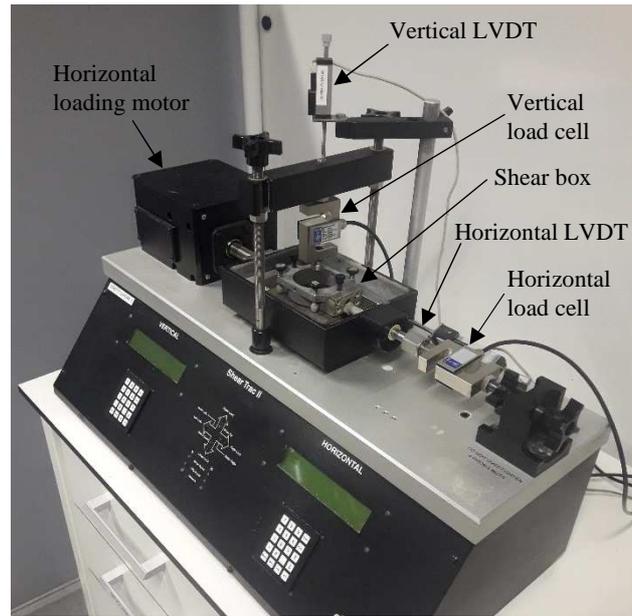
Figure 1. Interface shear test device.

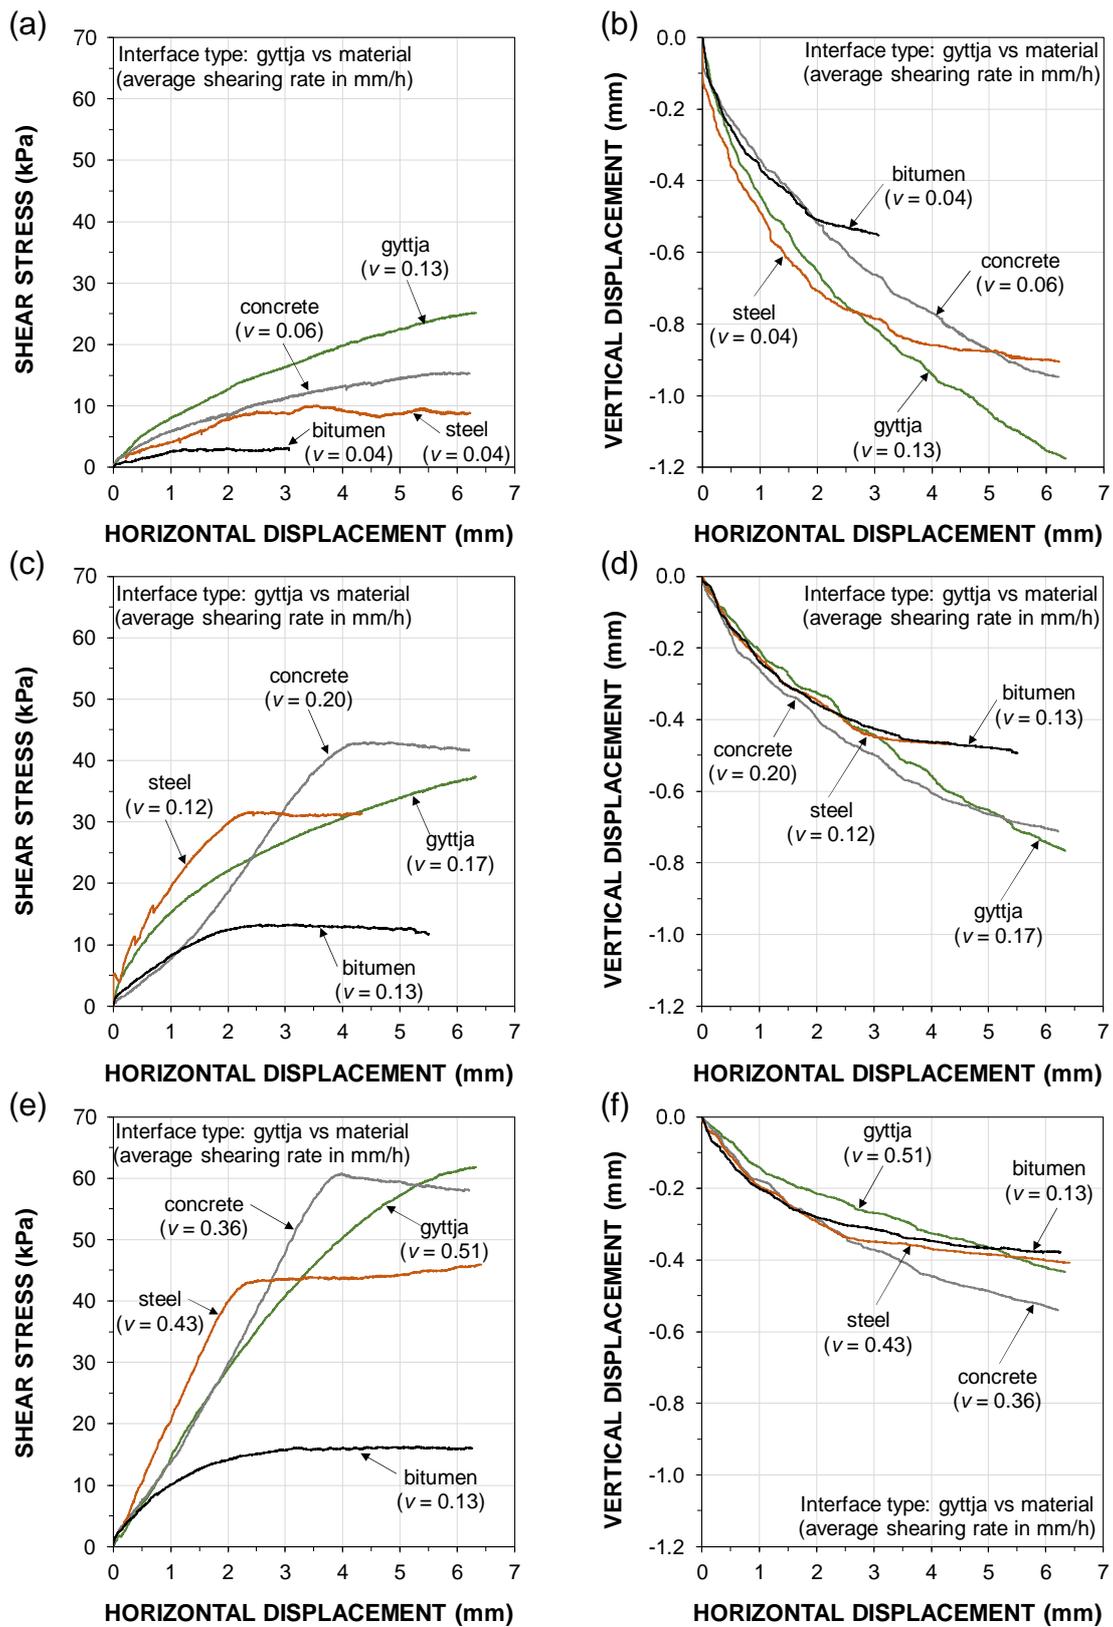
Figure 2. Shear stress and vertical displacement versus horizontal displacement from tests performed at: (a) and (b) 20 kPa, (c) and (d) 40 kPa, and (e) and (f) 60 kPa normal stress, respectively.

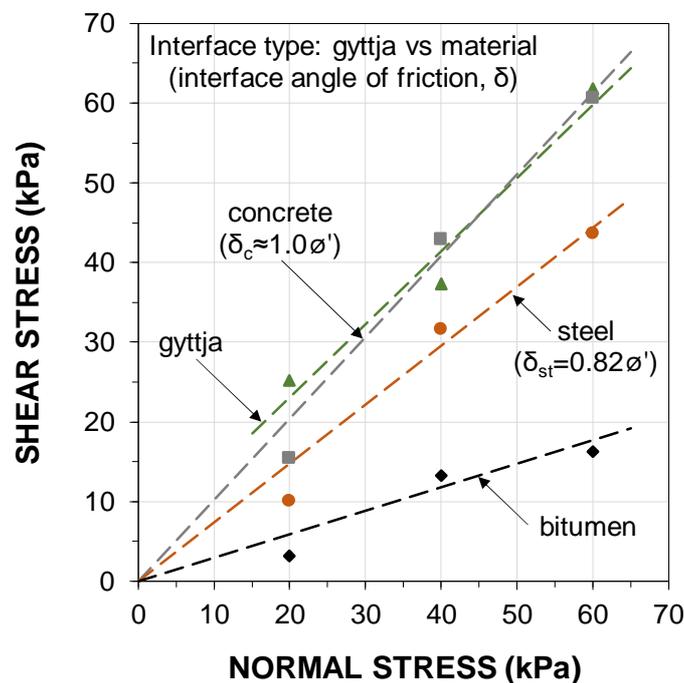
Figure 3. The maximum mobilised shear stress versus normal stress obtained from interface shear tests.

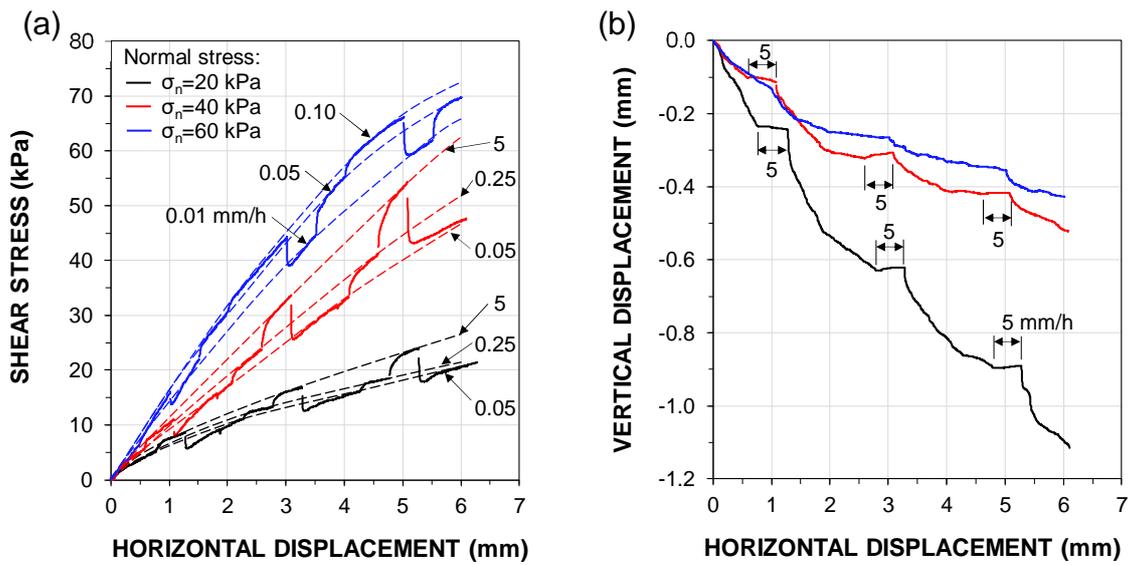
Figure 4. (a) Shear stress and (b) vertical displacement versus horizontal displacement at different normal stresses and shearing rates performed on a soil against soil sample.

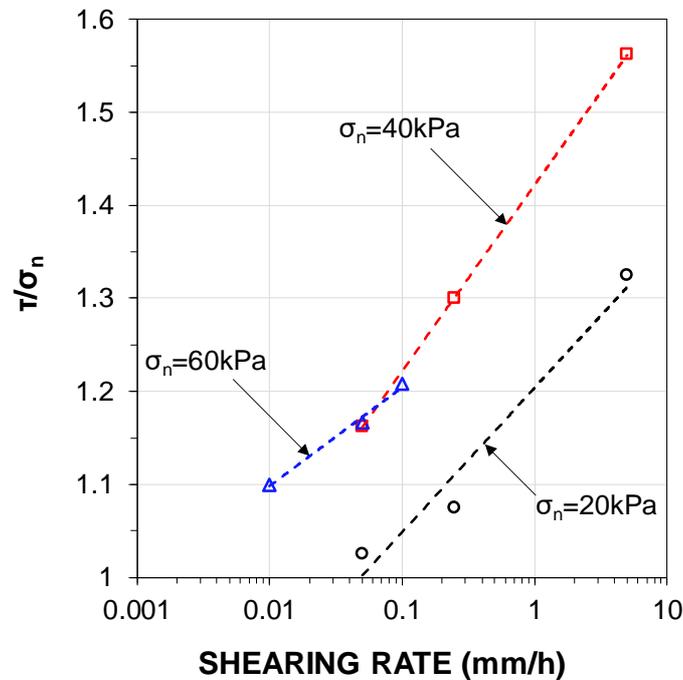
Figure 5. Normalized shear stress versus shearing rate (a gyttja sample).

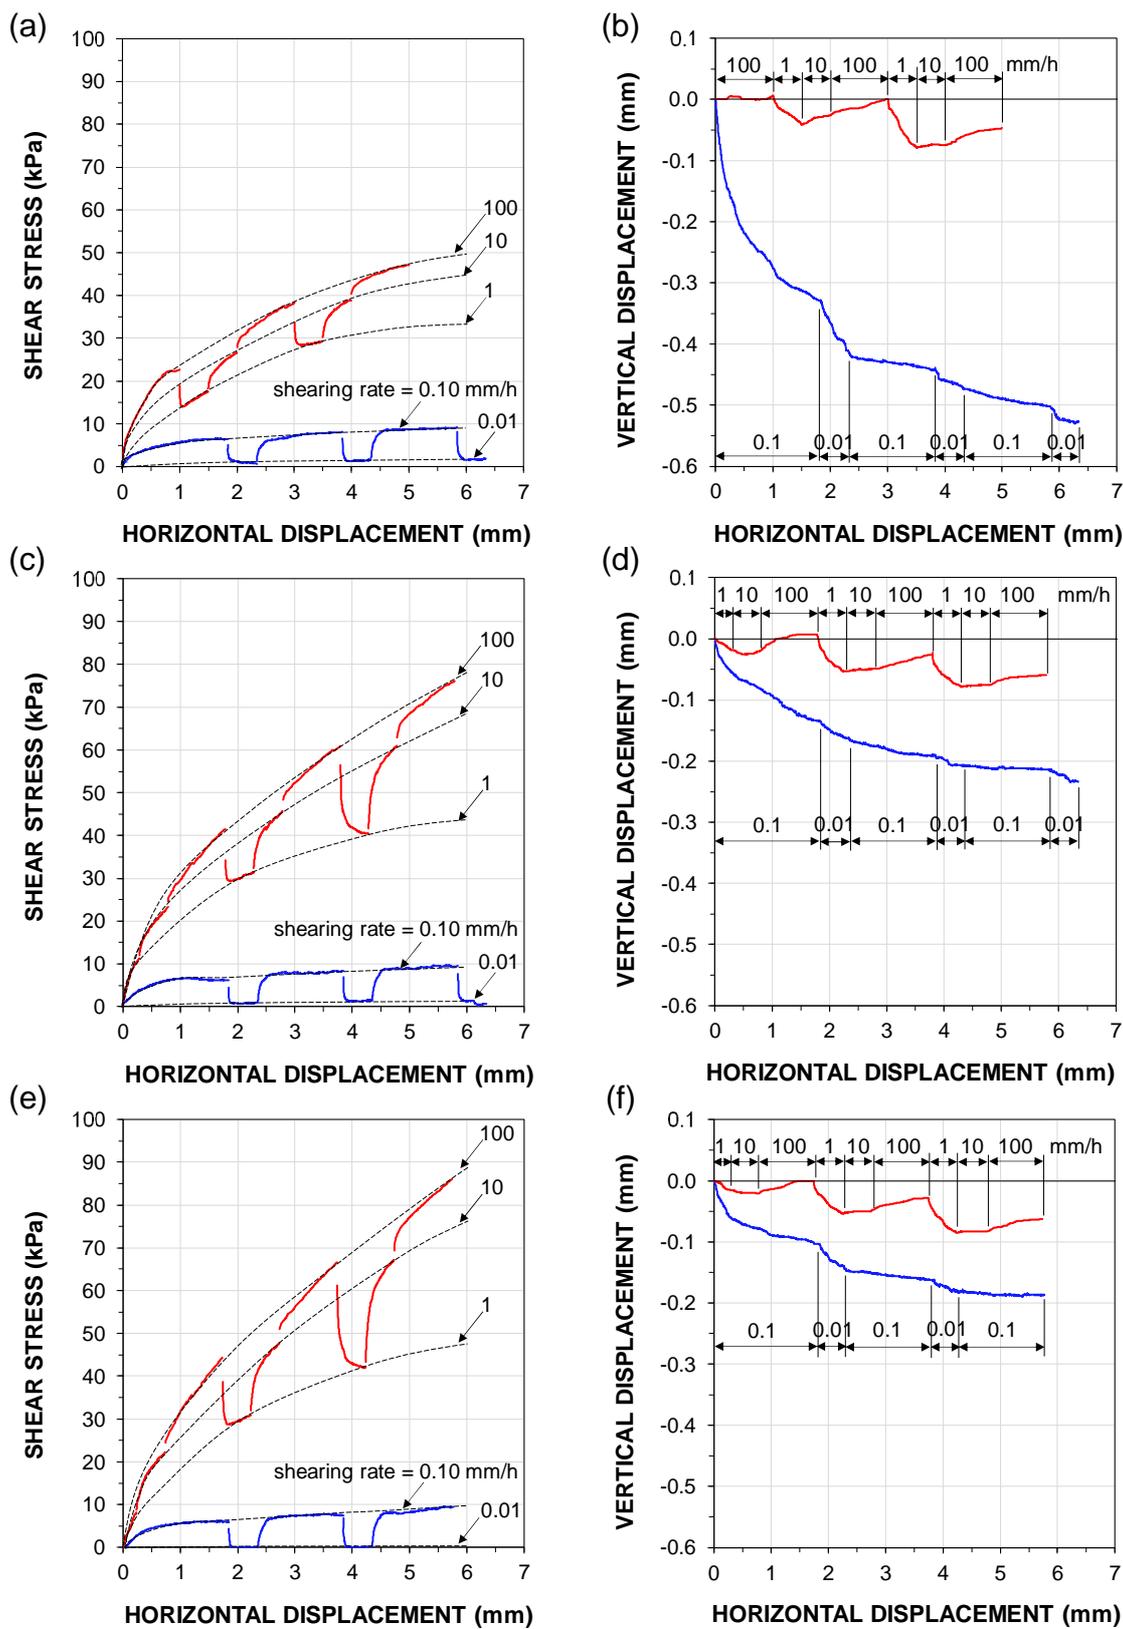
Figure 6. Shear stress and vertical displacement versus horizontal displacement from tests performed at: (a) and (b) 40 kPa, (c) and (d) 60 kPa, and (e) and (f) 80 kPa normal stress, respectively, and different shearing rates.
