SOIL-PILE INTERACTION IN SOFT SOILS

PhD Dissertation

AARHUS
UNIVERSITY
DEPARTMENT OF ENGINEERING

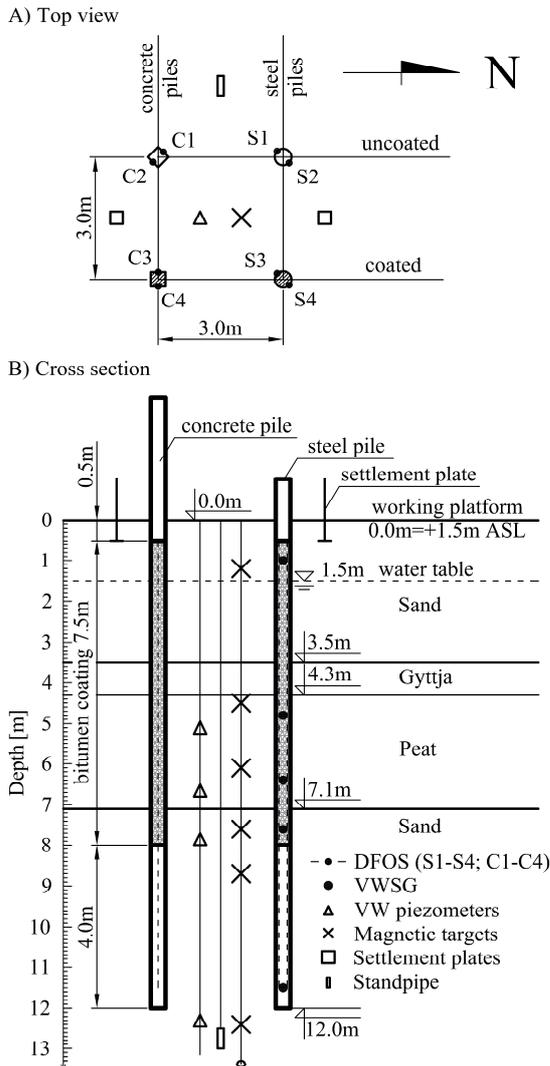
Figure 1. Soil profile and the test setup.

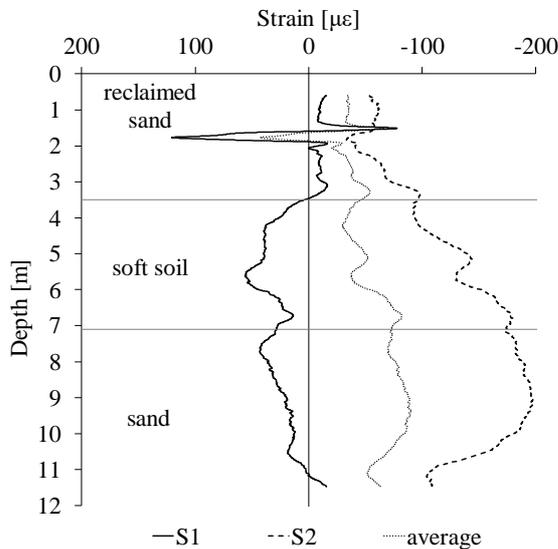
Figure 4. Measured strain distribution of opposite mounted DFOS on the uncoated steel test pile after pile installation

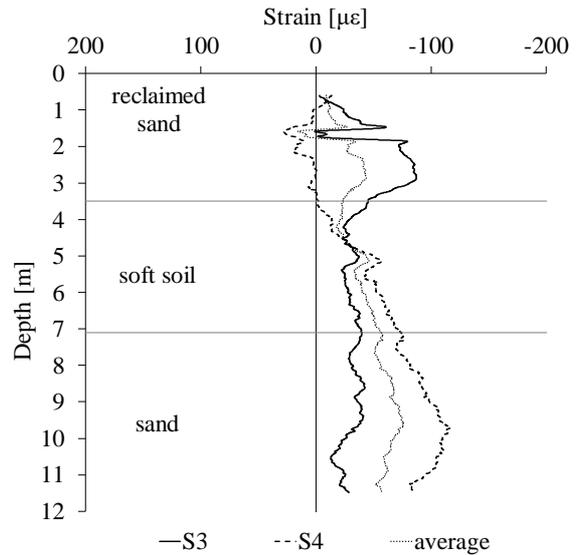
Figure 5. Measured strain distribution of opposite mounted distributed fibre optic sensor on the coated steel test pile after pile installation

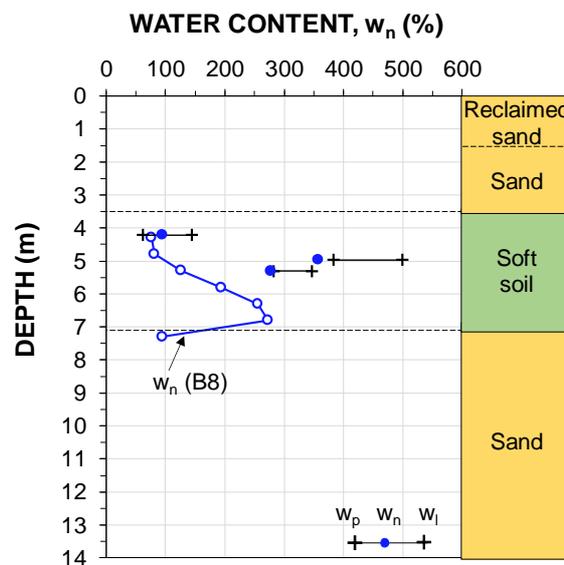
Figure 1. Soil profile, atterberg limits (soil samples collected in connection to the installation of in-situ monitoring equipment for the test setup on January 16-18, 2018) and distribution of water content (soil boring B8 performed on October 15, 2008)

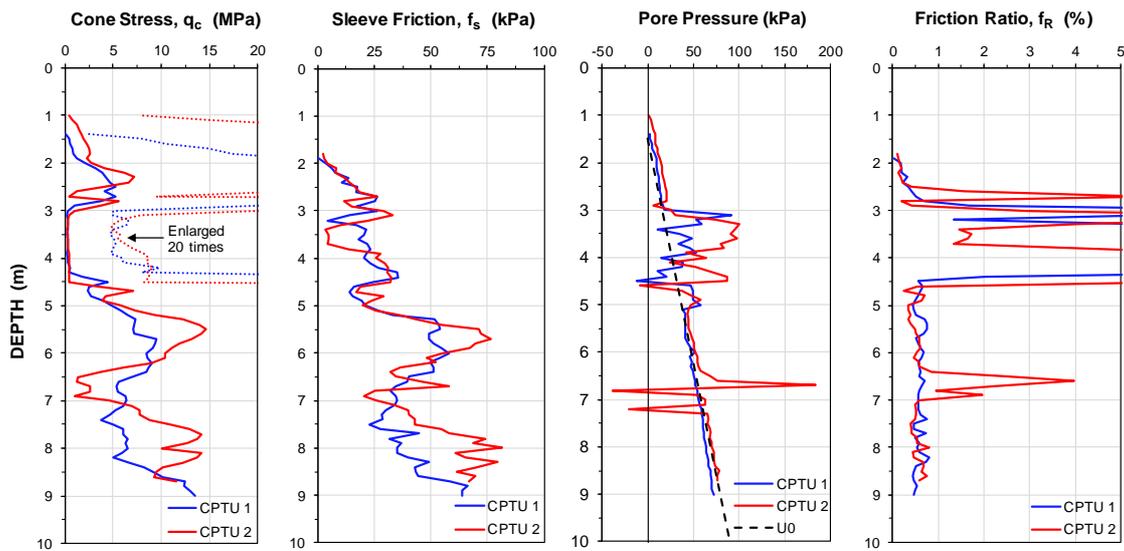
Figure 3. CPTU diagrams (CPTU 1 and CPTU 2 from soundings pushed about 55 m and 70 m from the test piles on February 17-20, 2017).

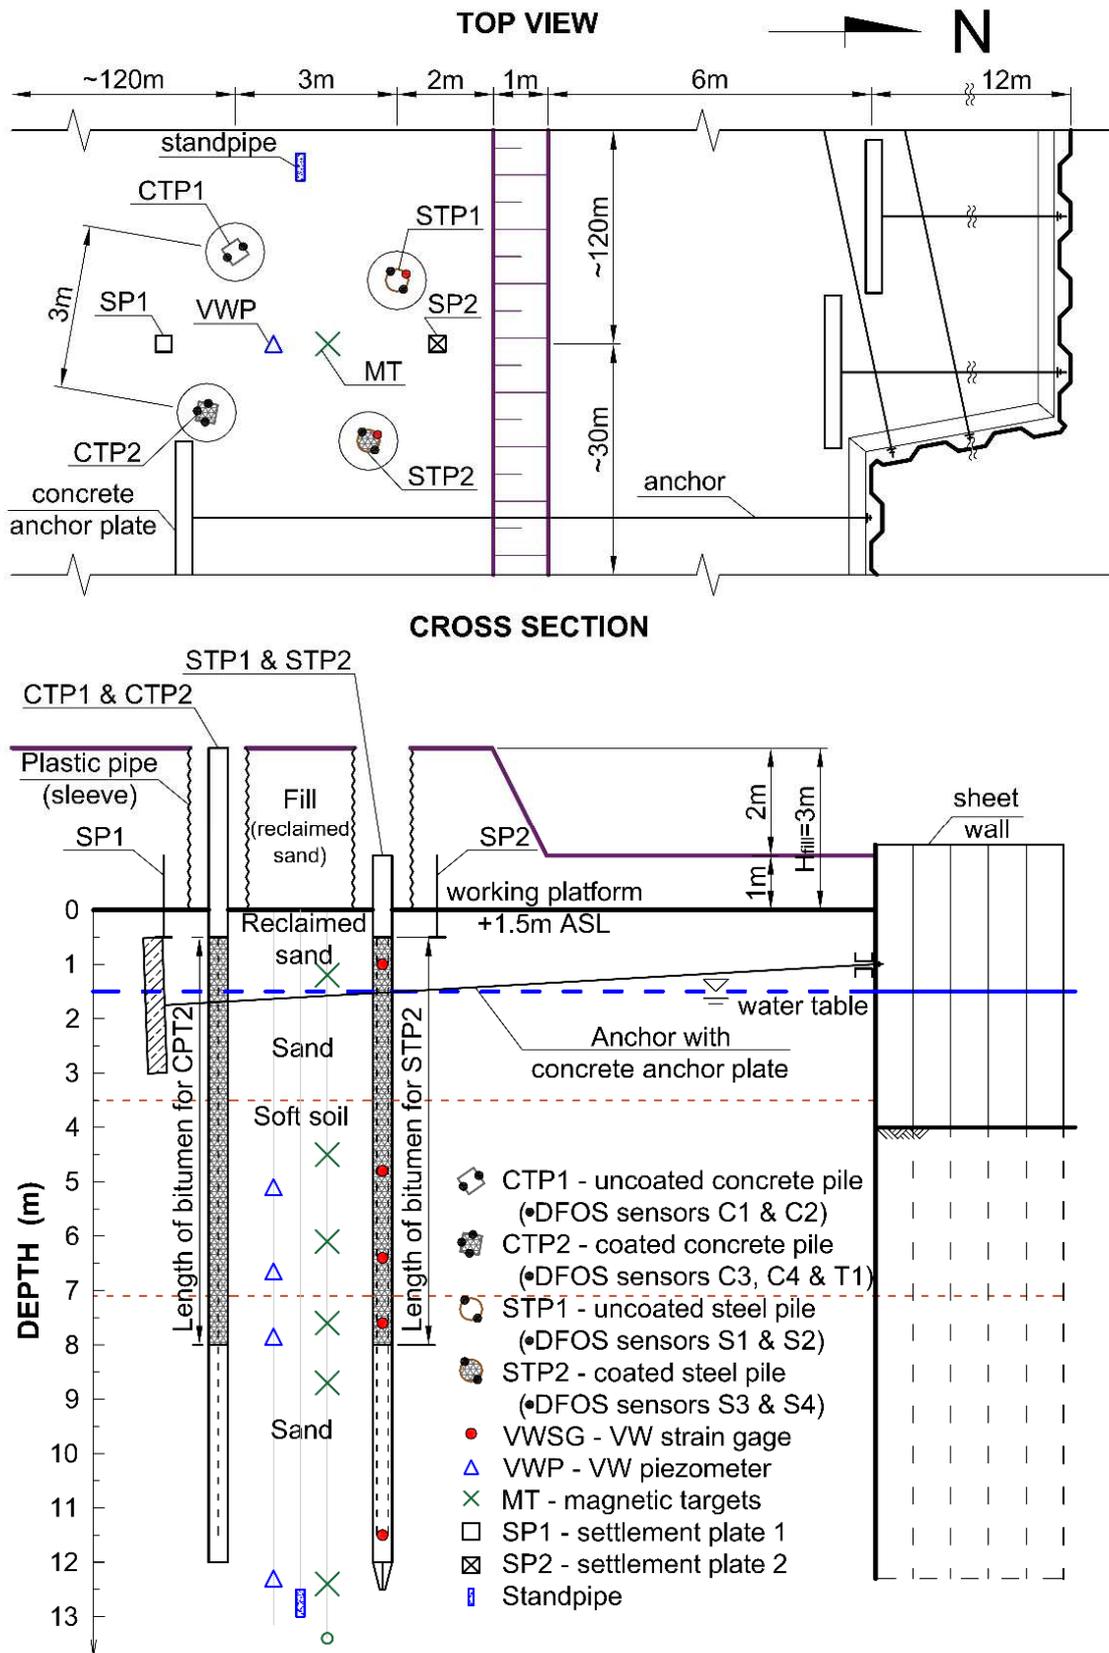
Figure 4. Soil profile and the test setup.

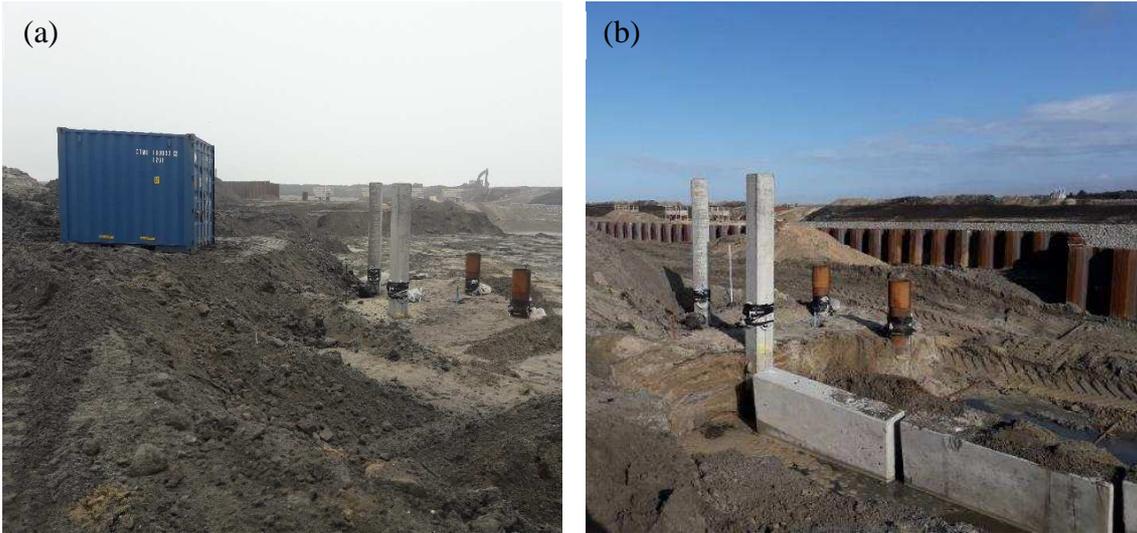
Figure 6. Test site at (a) Day 78 and (b) Day 126 (before placing the 3.0 m fill). The concrete slabs in (b) are anchor plates for the sheet pile wall seen in the background.

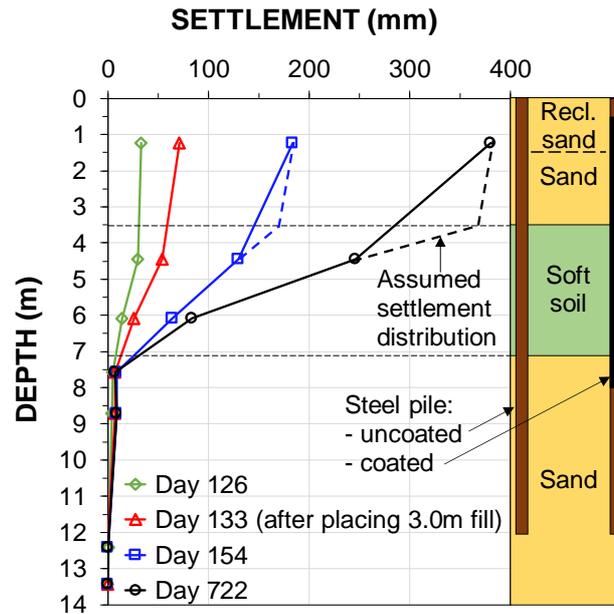
Figure 7. Soil settlement profiles at selected days after pile driving.

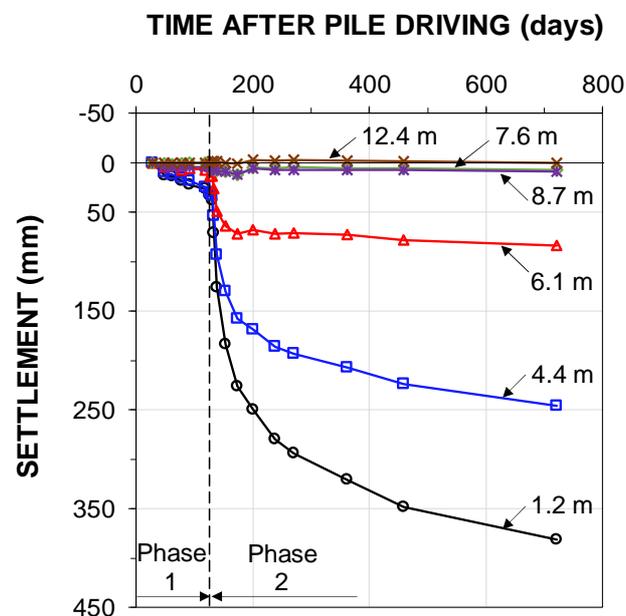
Figure 8. Settlement of individual gages with time after pile driving.

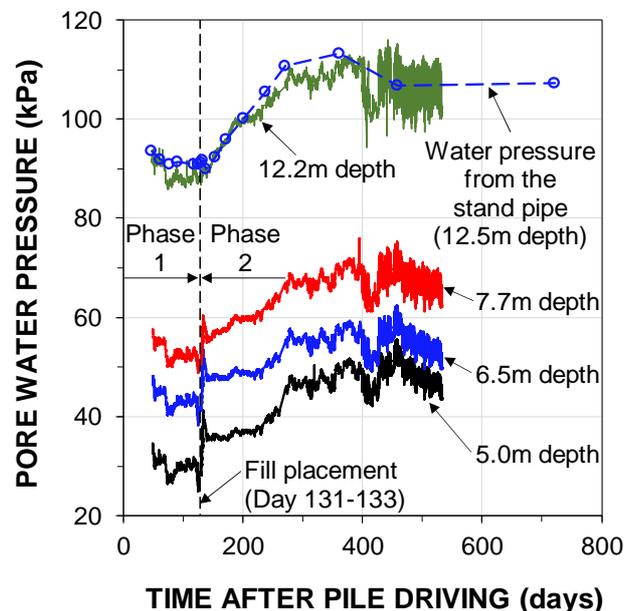
Figure 9. Pore water pressure recorded from individual piezometers located at different depths and the water pressure calculated from the standpipe water level records.

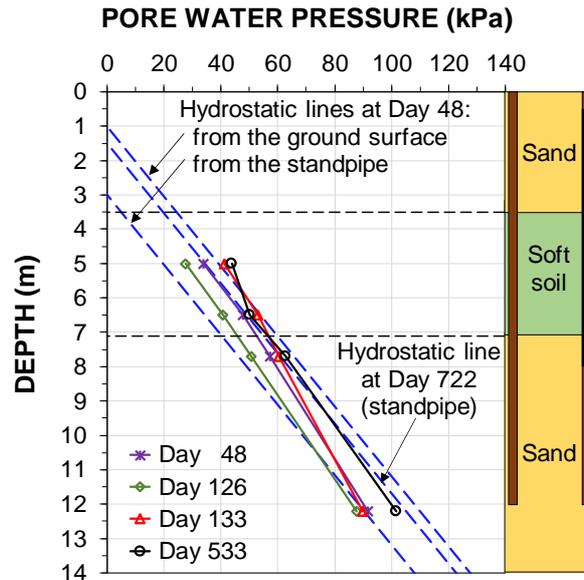
Figure 10. Pore water pressure profiles at selected days after pile driving.

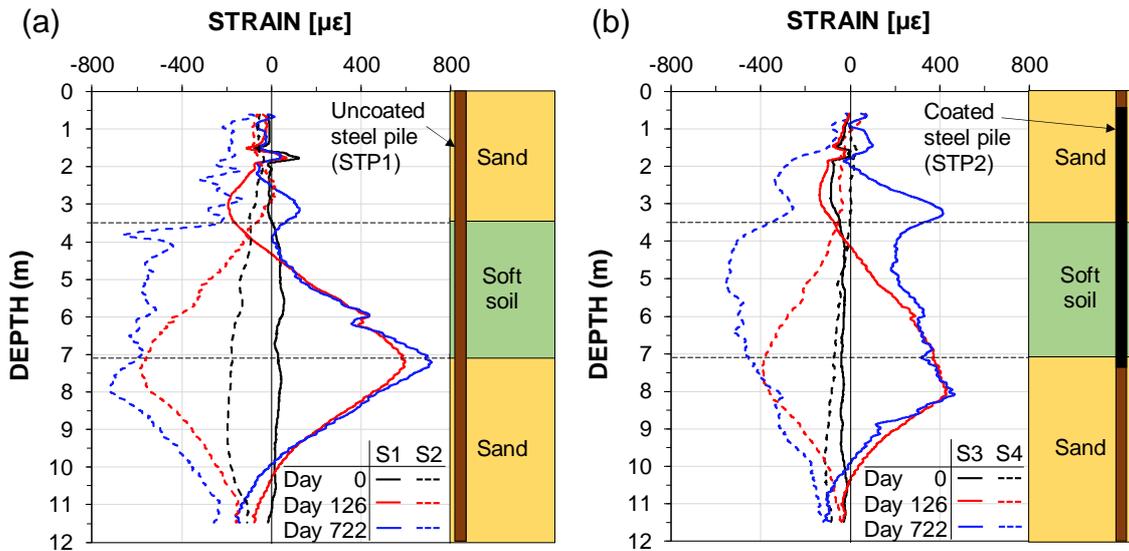
Figure 11. Strain profiles in (a) the uncoated steel pile (sensor S1 and S2) and (b) coated steel pile (sensor S3 and S4). The plots show measured data immediately after driving (Day 0), before placing the fill (Day 126), and 589 days after placing the fill (Day 722).

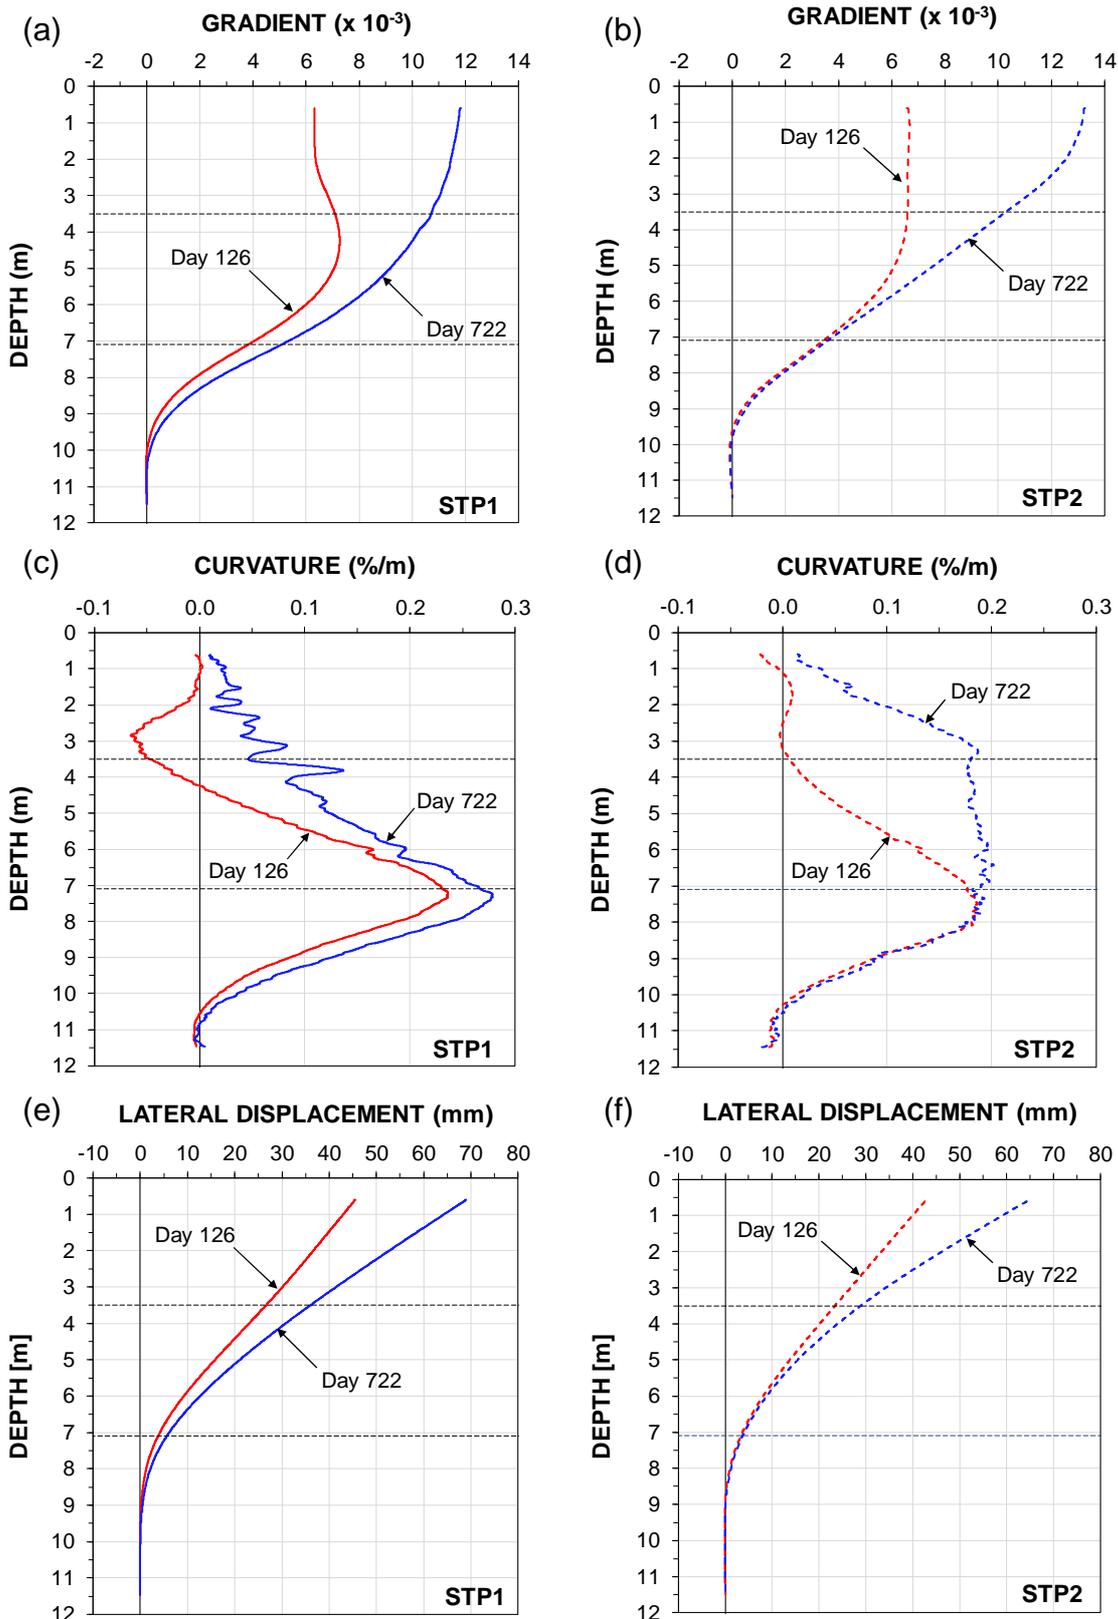
Figure 12. Curvature ((a) and (b)), gradient ((c) and (d)) and lateral displacement ((e) and (f)) of the uncoated (STP1) and bitumen coated (STP2) steel test pile recorded at Day 126 (before placing the fill) and Day 722 (589 days after the end of placing the fill). Data for STP1 at Day 126 from Kania et al. 2020.

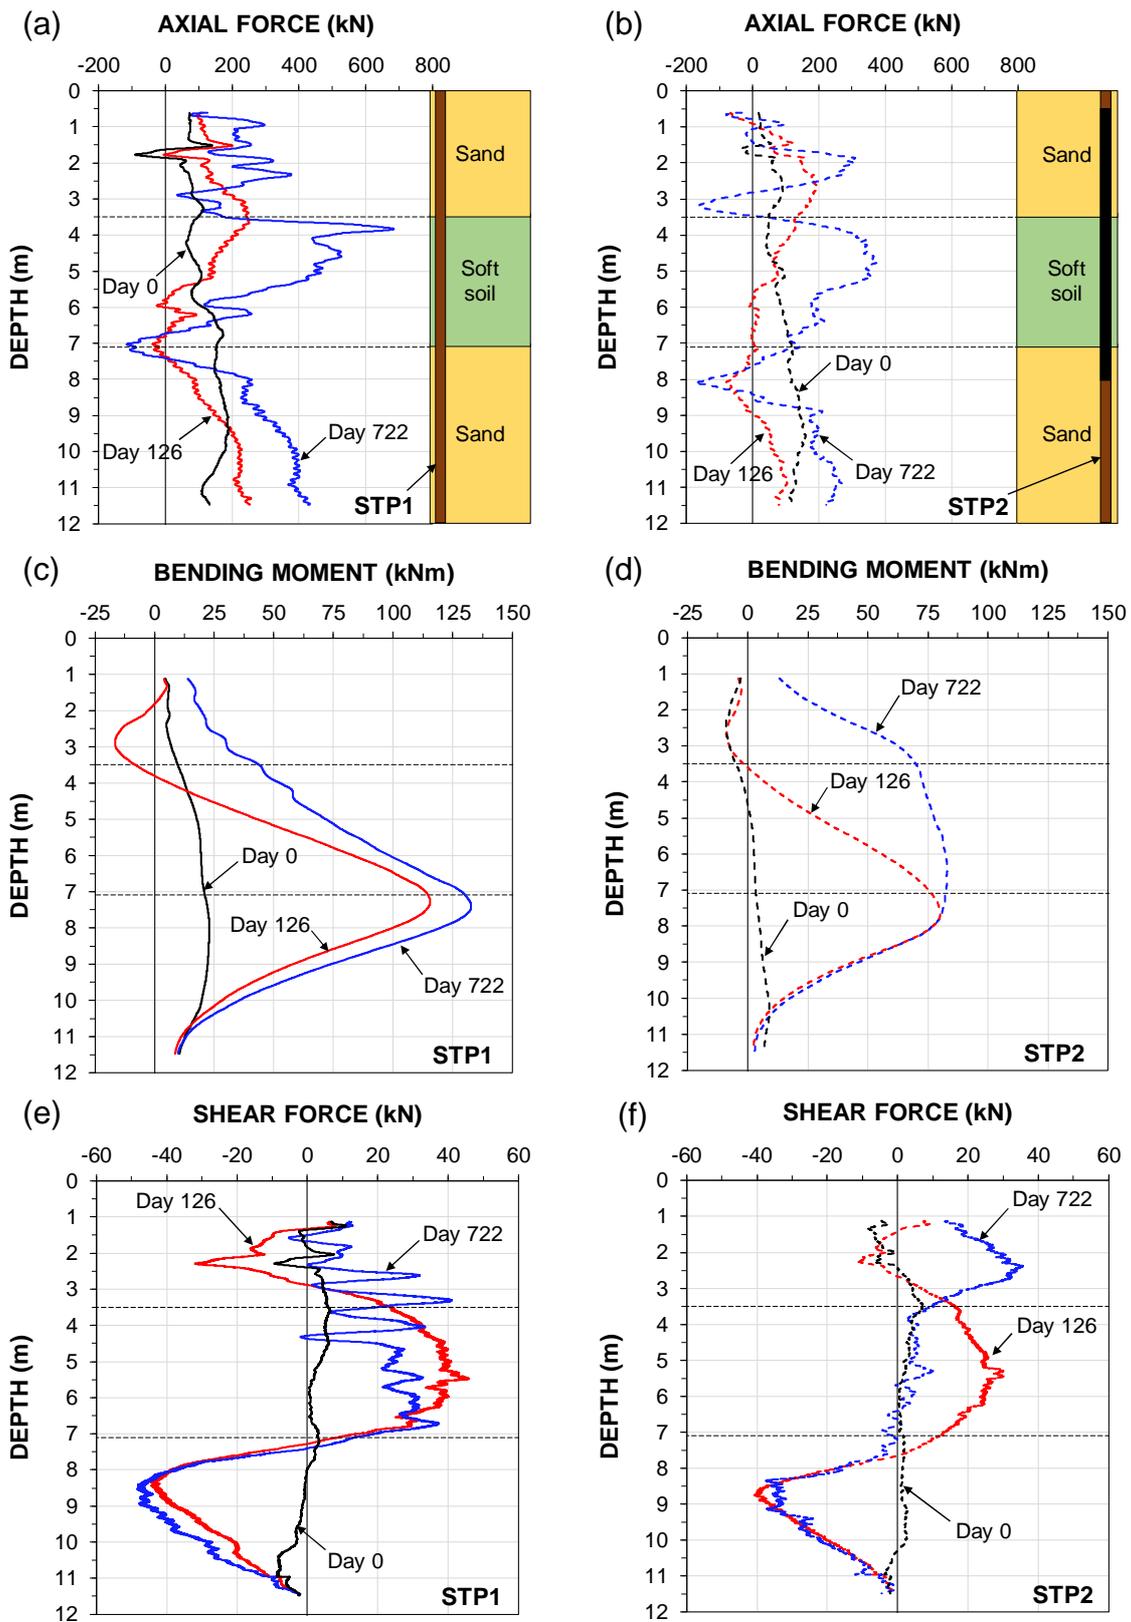
Figure 13. Axial force ((a) and (b)), bending moment ((c) and (d)) and shear force ((e) and (f)) along the uncoated (STP1) and bitumen coated (STP2) steel test pile recorded at Day 0 (immediately after driving), Day 126 (before placing the fill) and Day 722 (589 days after the end of placing the fill).

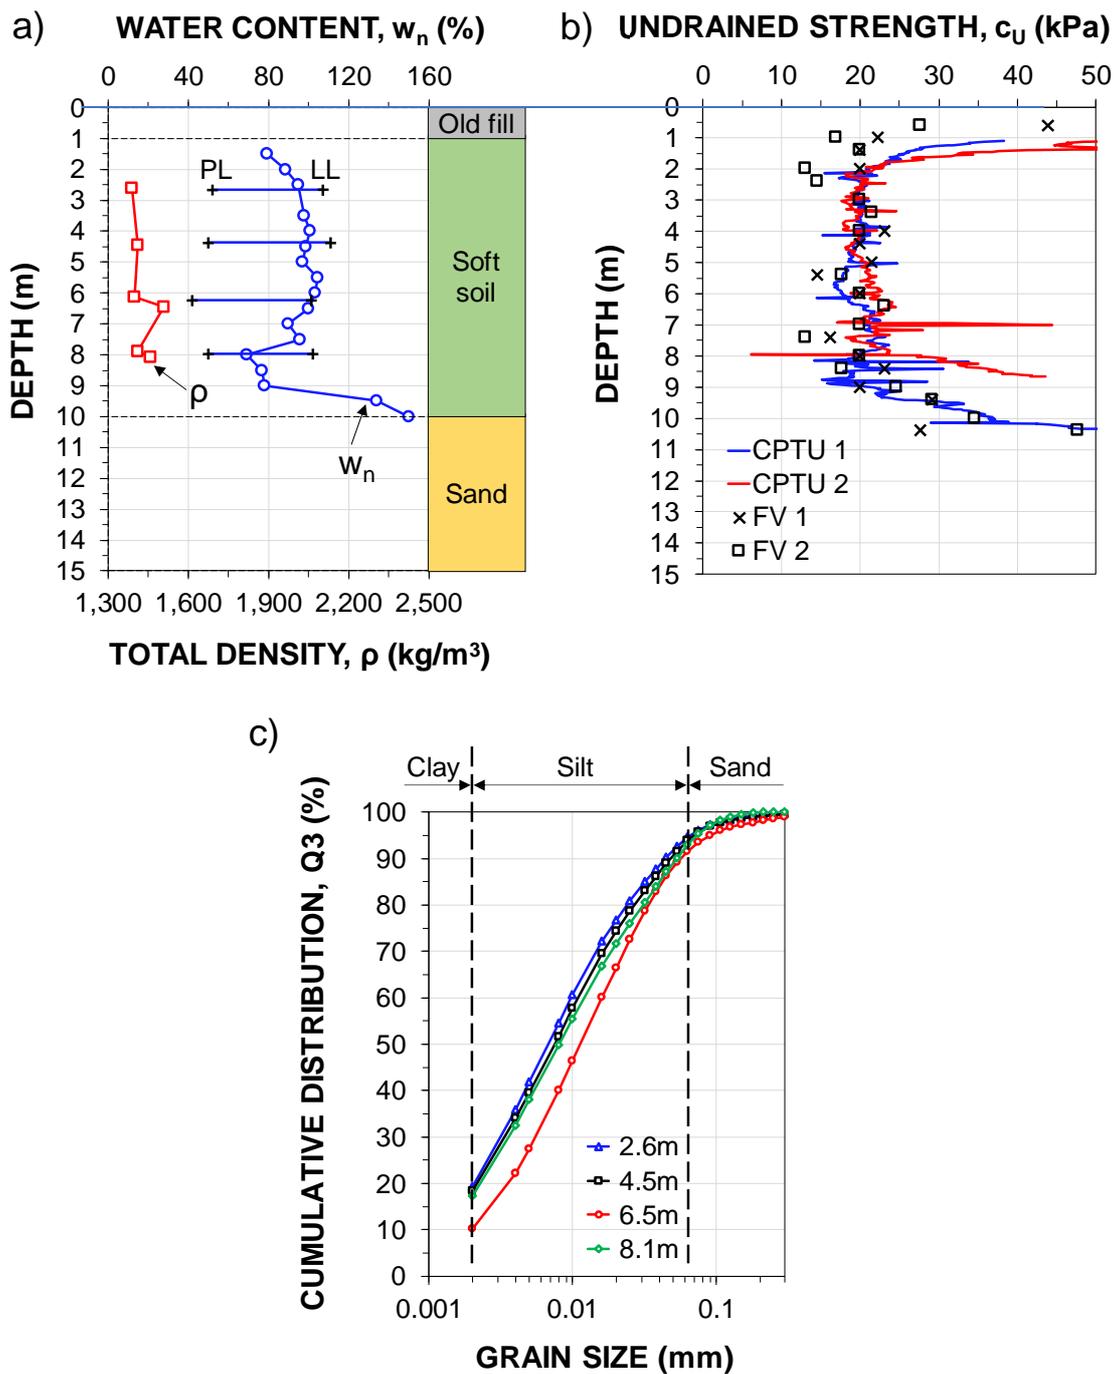
Figure 1. Soil properties: a) Atterberg limits and water content, b) undrained shear strength, c) grain size distribution by laser diffraction (data from Savery 2019).

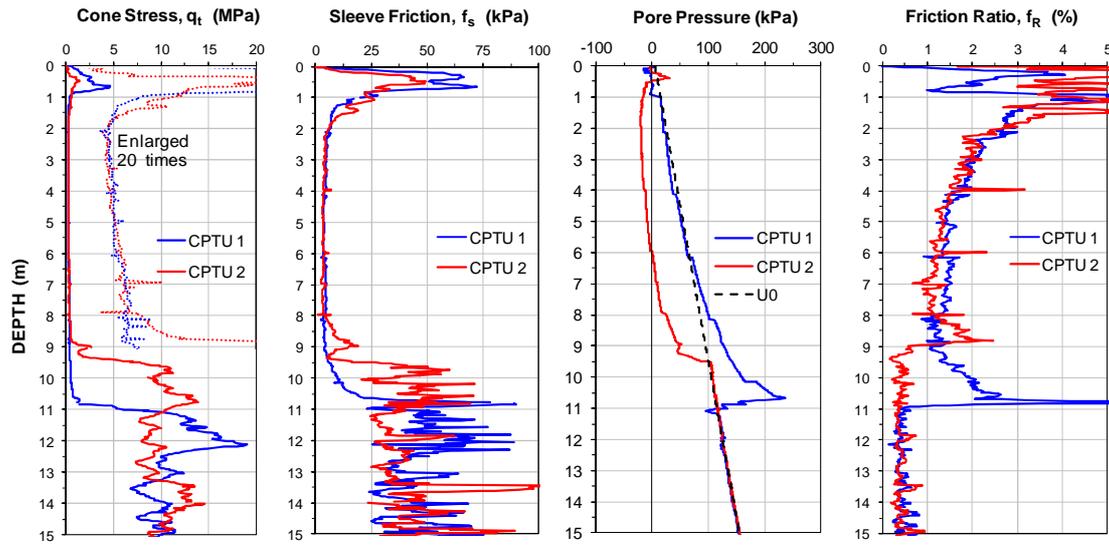
Figure 2. CPTU diagrams.

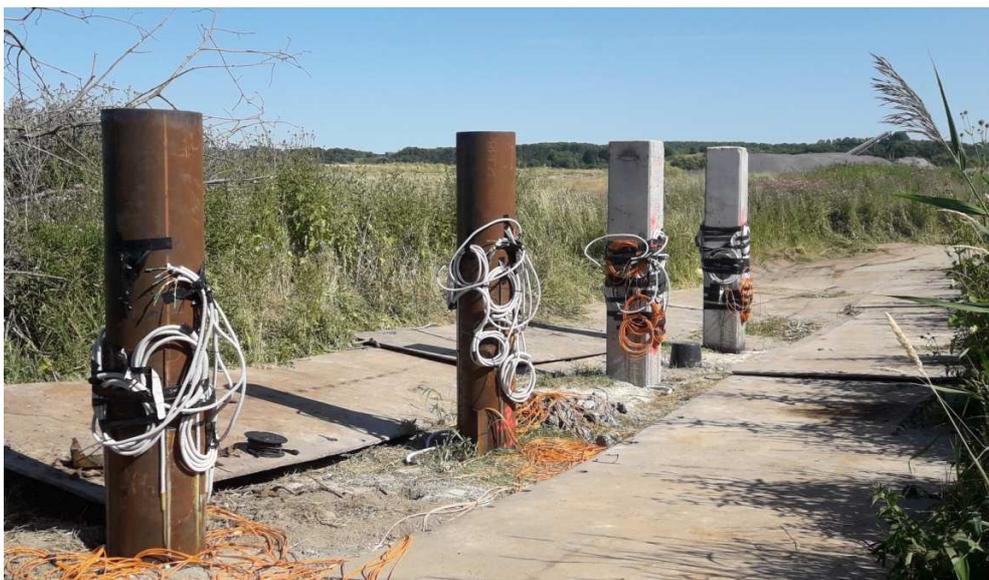
Figure 3. Photo of test piles after completed installation.

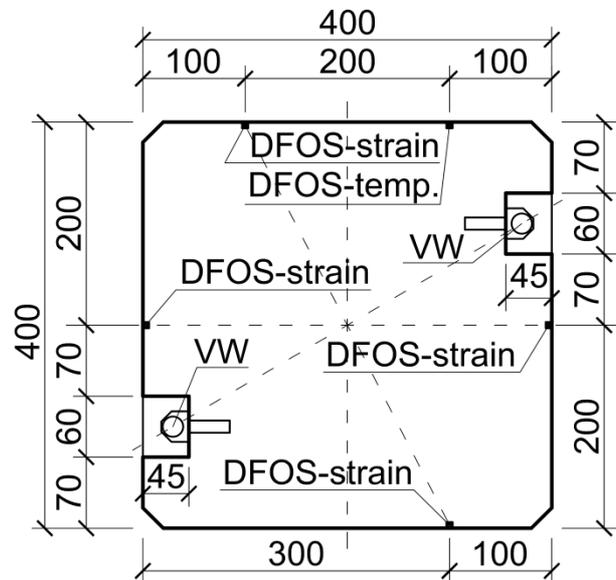
Figure 6. Cross-section of the instrumented precast concrete test pile

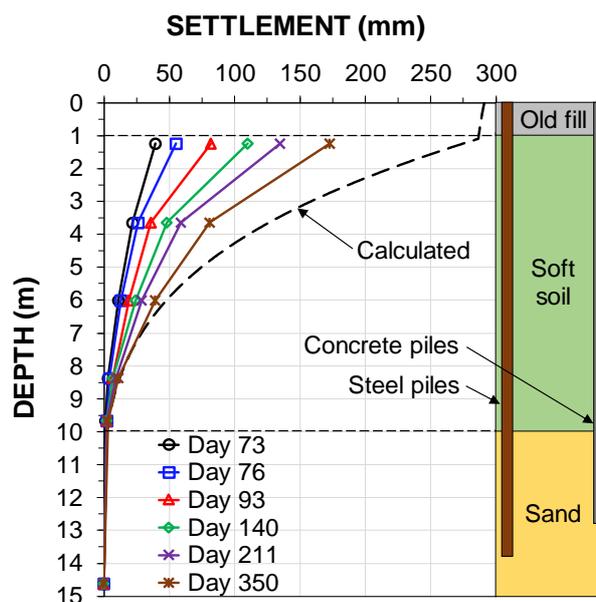
Figure 9. Soil settlement profiles due to placing of the fill at selected days after driving

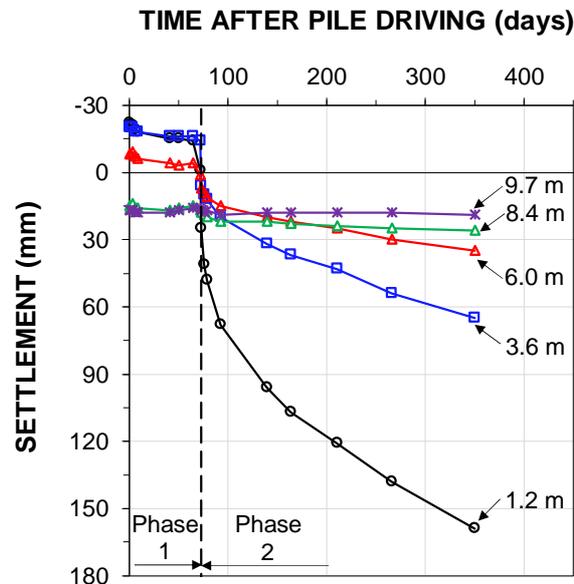
Figure 10. The settlement of individual gages with time after pile driving.

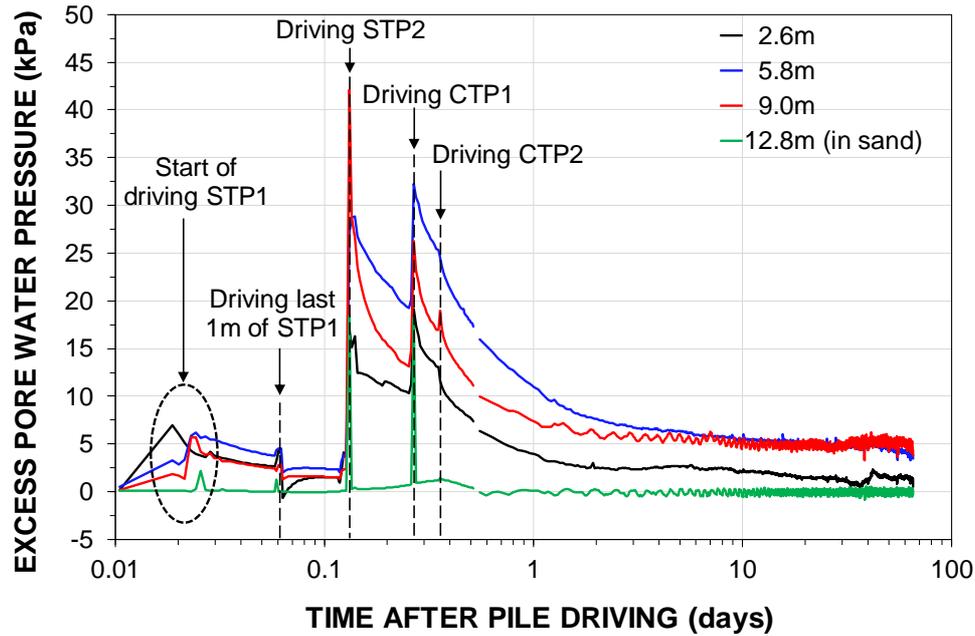
Figure 11. Excess pore water pressure due to pile installation and its dissipation with time until Day 65 (Phase 1).

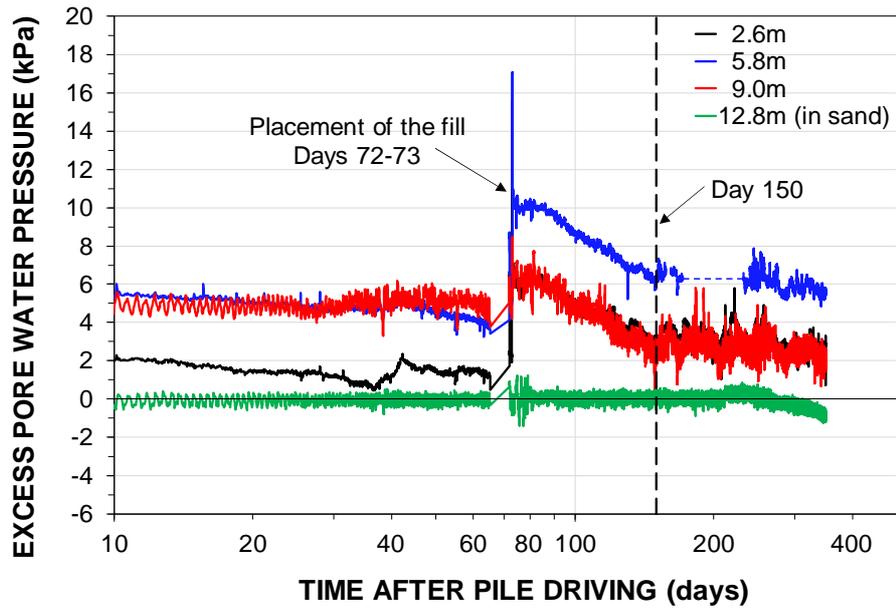
Figure 12. Excess pore water dissipation with time after placing the fill.

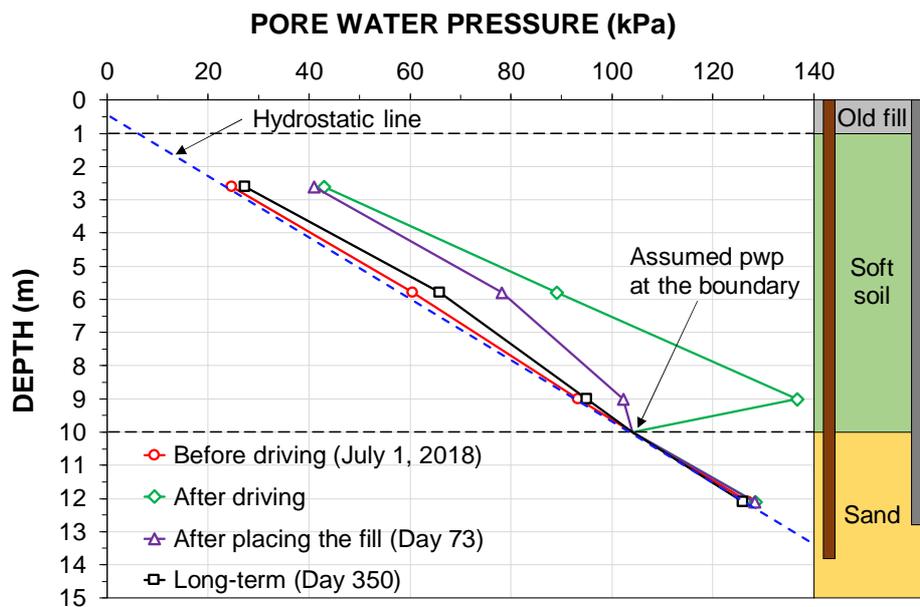
Figure 13. Pore water pressure, pwp, profiles with depth: hydrostatic, before driving, maximum measured after driving (July 3, 2018), maximum measured after placing the fill (Day 73) and final long-term (Day 350).

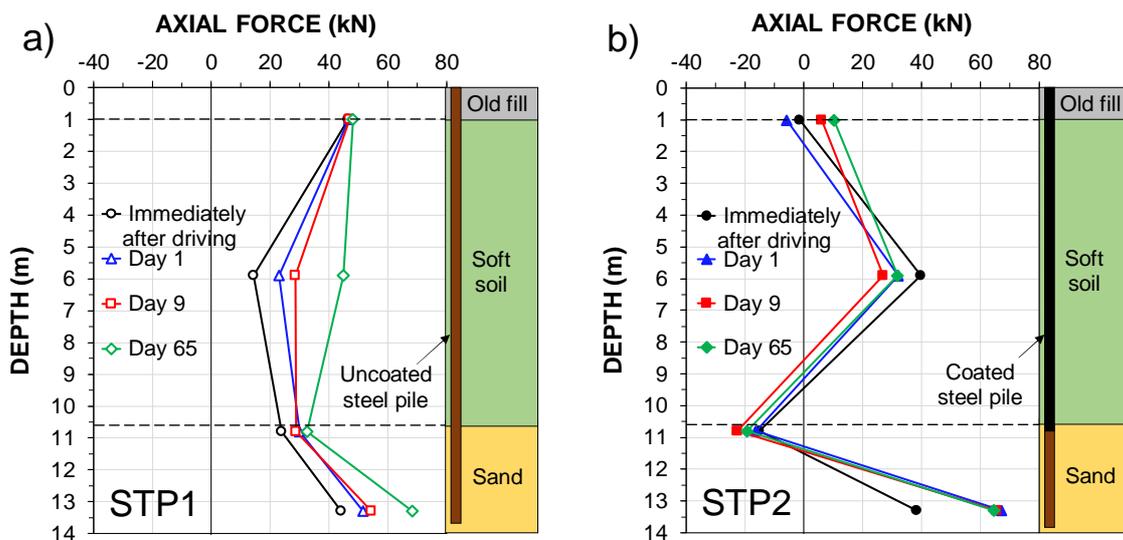
Figure 14. Axial force distribution along the a) STP1 (uncoated steel pile) and b) STP2 (coated steel pile)

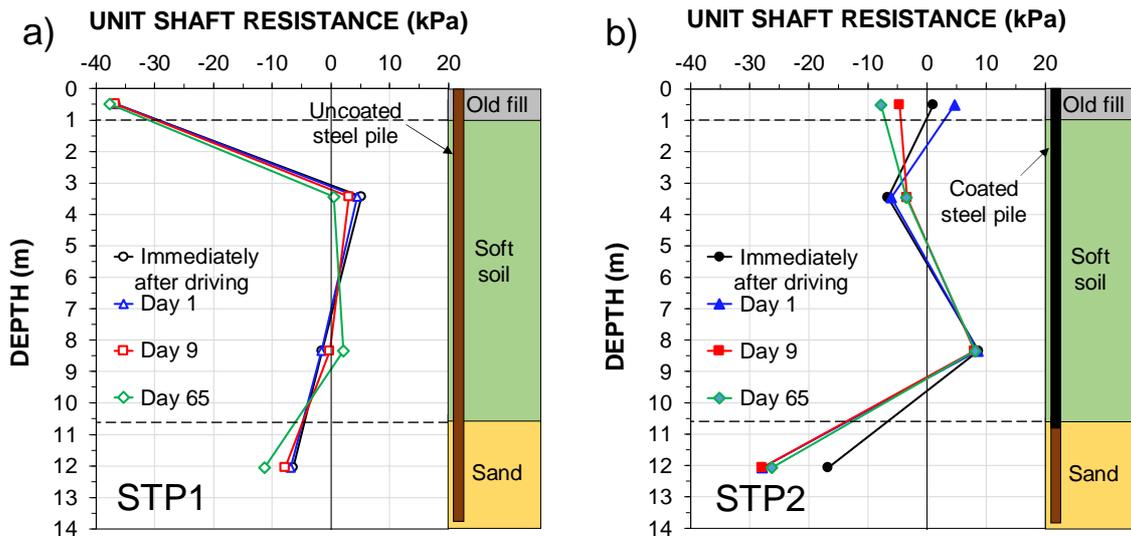
Figure 15. Unit shaft resistance along the a) STP1 and b) STP2 immediately and at selected days after driving.

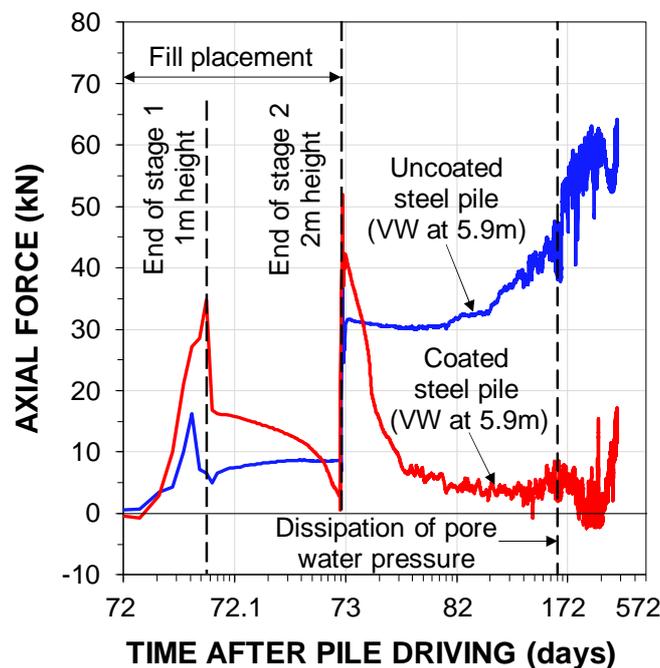
Figure 17. Axial force at 5.9 m depth along the STP1 (uncoated) and STP2 (bitumen coated) with days after fill placement.

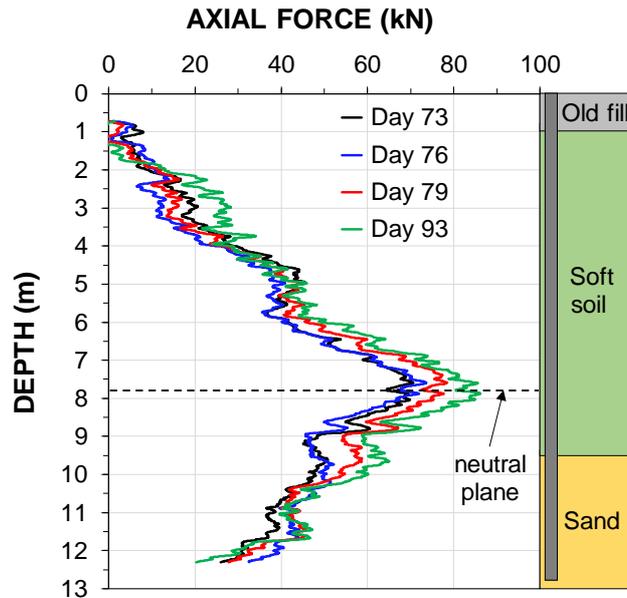
Figure 18. Axial force distribution (determined from the DFOS data) along the uncoated precast concrete pile (CTP1) at selected days after placing the fill.

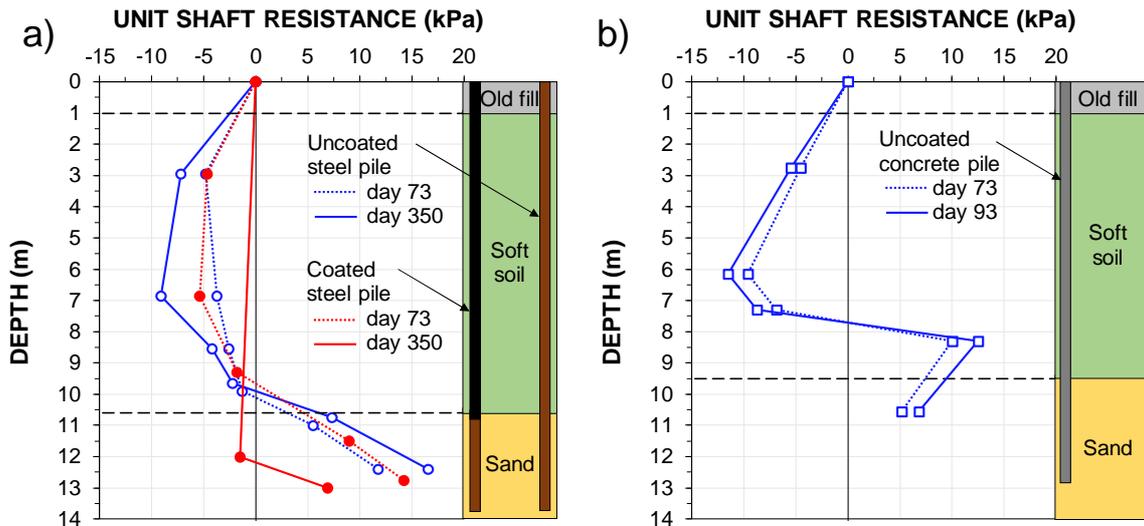
Figure 19. Unit shaft resistance distributions with depth along: a) the uncoated (STP1) and the bitumen coated (STP2) steel test pile immediately (Day 73) and 277 days after placing the fill (Day 350) and b) the uncoated precast concrete pile (CTP1) immediately (Day 73) and 20 days after placing the fill (Day 93).

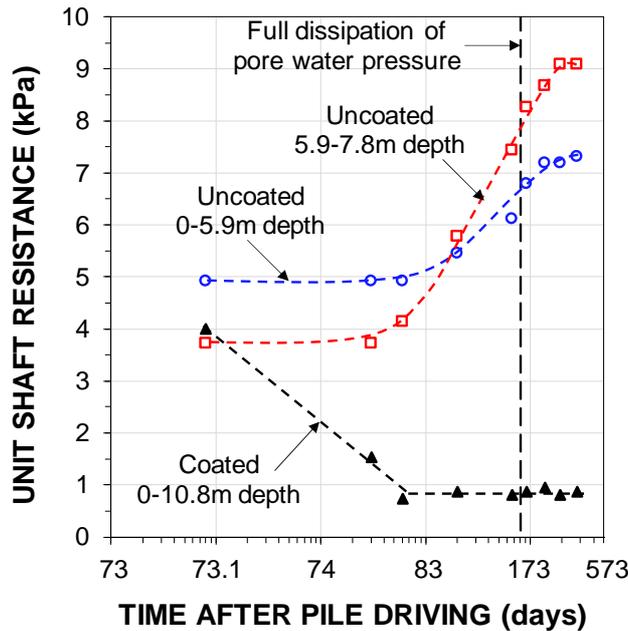
Figure 20. Development of negative skin friction along the uncoated STP1 (at two determined soil layers above transition zone) and the bitumen coated STP2 (entire bitumen coated section of the pile).

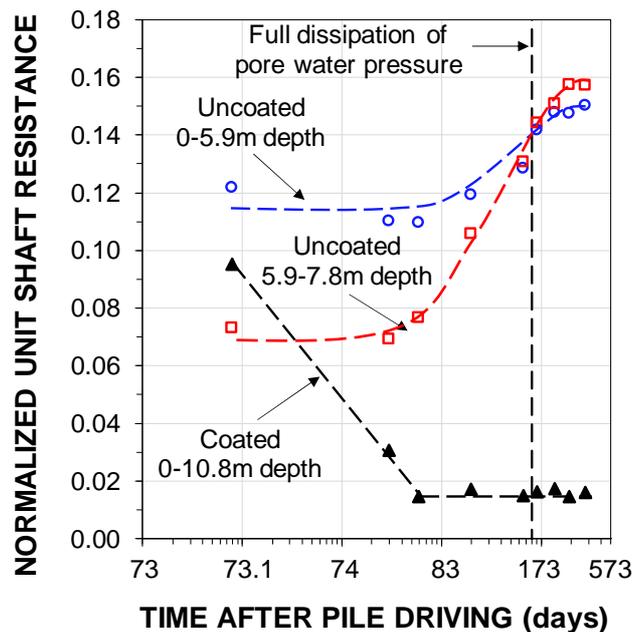
Figure 21. Development of the beta-coefficient (unit shaft resistance normalized by vertical effective stress) along the uncoated STP1 (at two determined soil layers above transition zone) and the bitumen coated STP2 (entire bitumen coated section of the pile).

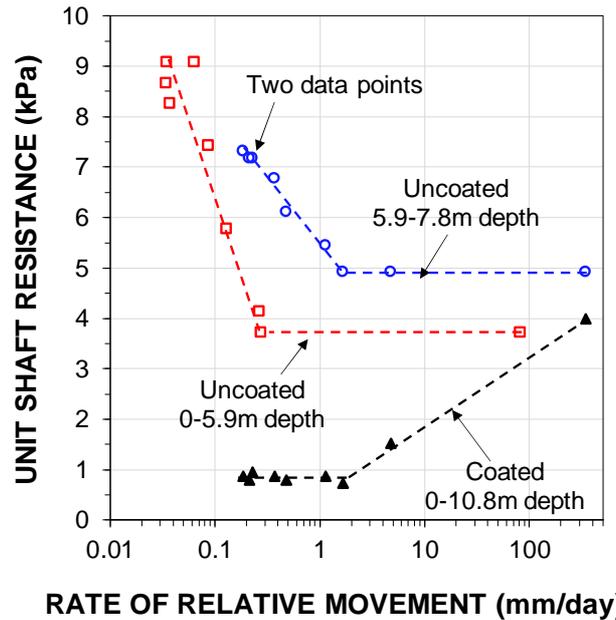
Figure 22. Development of negative skin friction along the uncoated (STP1) and bitumen coated (STP2) pile versus rate of relative movement.

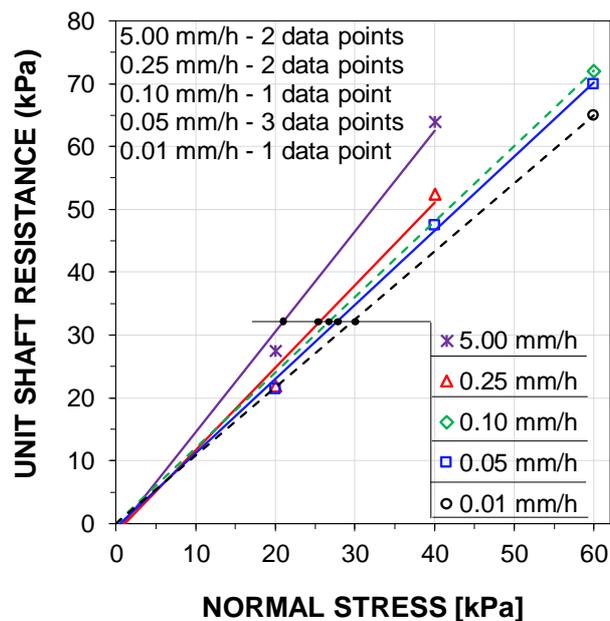
Figure 23. Direct shear test results on an undisturbed soft soil sample with different shearing rates.

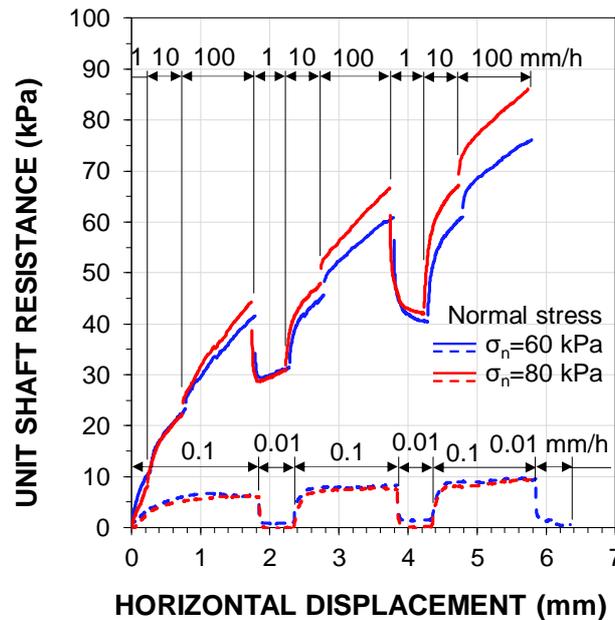
Figure 24. Unit shaft resistance curves from laboratory tests on soft soil samples at $\sigma_n = 60$ kPa and $\sigma_n = 80$ kPa against bitumen coated concrete block.
